# PROPERTY INSPECTION REPORT

## “AROUND THE HOUSE” HOME INSPECTIONS

By: **David J. Stiles Inspector Lic. #7308** **3/19/2019**

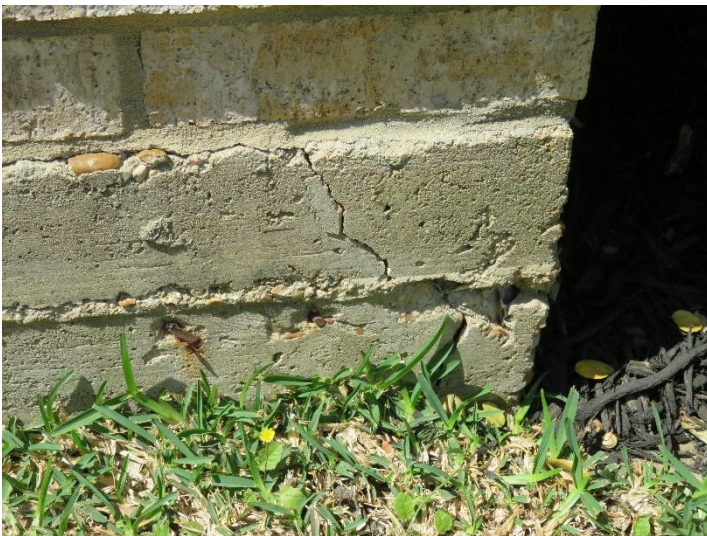
Example at the front left corner of the home

- “Corner pops or shears” may be present at one of more exterior concrete corners of the home. In the opinion of the inspector, these pops are common in Texas construction and do not normally reduce the strength of the foundation nor do they necessarily mean that structural integrity has been compromised. Post tension cables and/or structural re-bar installed behind the shears may be subject to water exposure, rust and deterioration. The corner pops/shears should be sealed. Any concerns should be addressed to a P.E. or structural engineer.

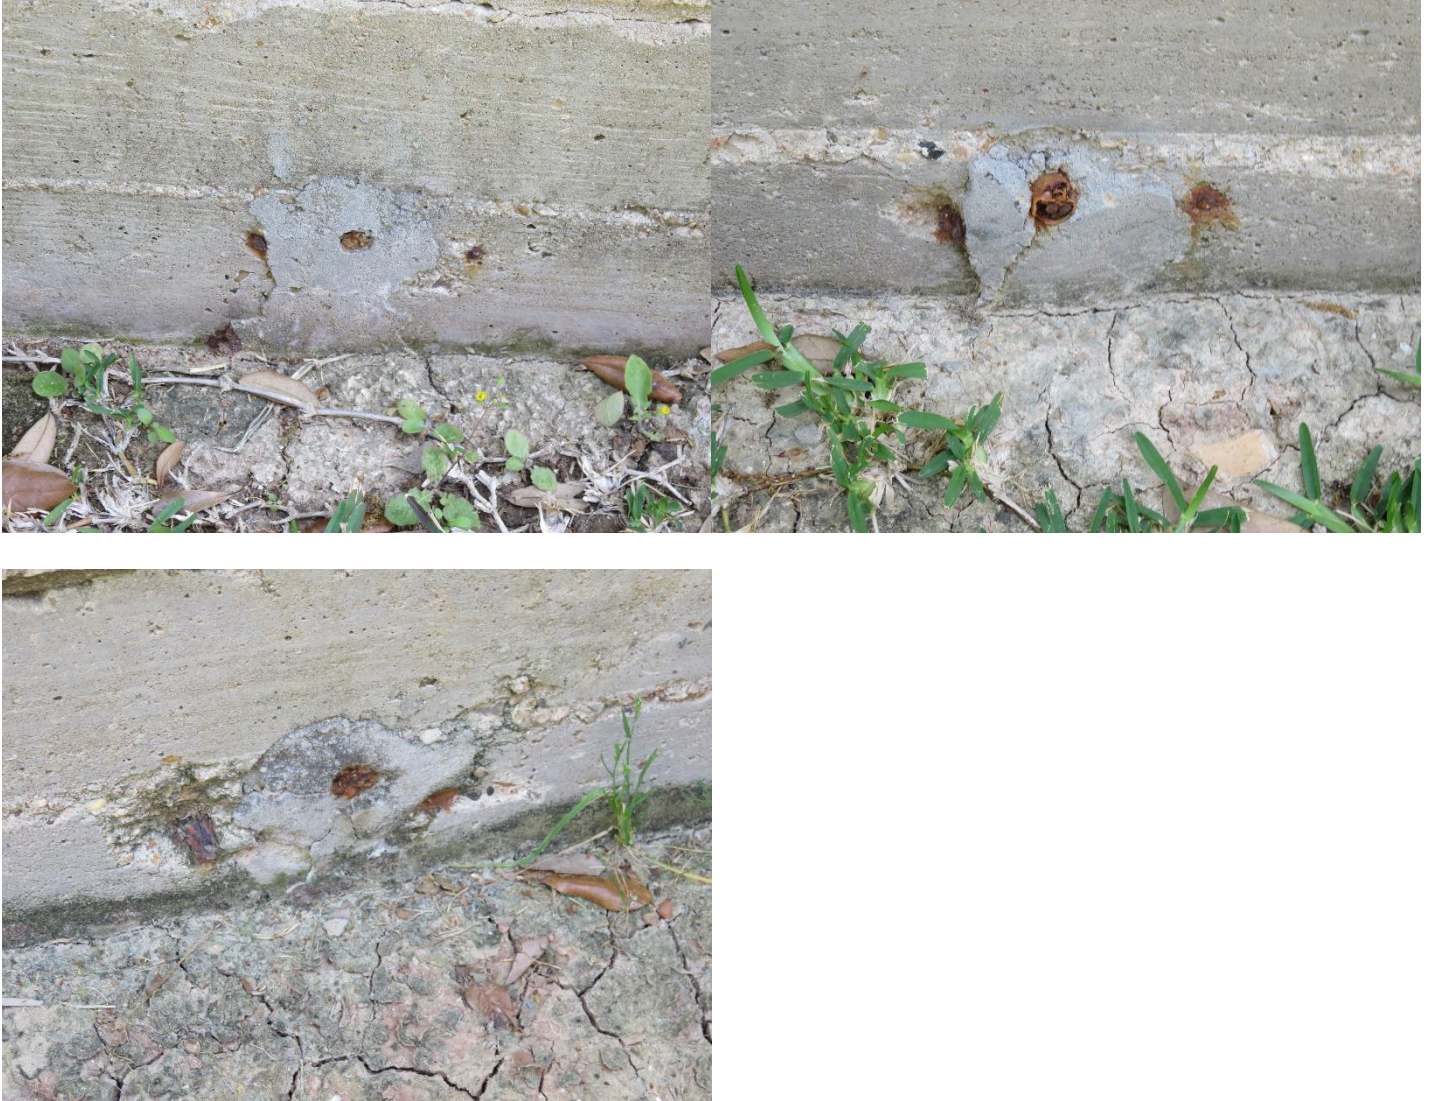
Examples on the right side of the home

- Post tension foundation cable ends about the home are exposed. Allowing these cable ends to remain exposed to moisture and weather elements could eventually cause the cable to weaken and possibly lose strength. Evaluation by a professional foundation contractor familiar with decay of post tensions cables may be required. All exposed cable ends should be properly covered/protected to prevent further deterioration.

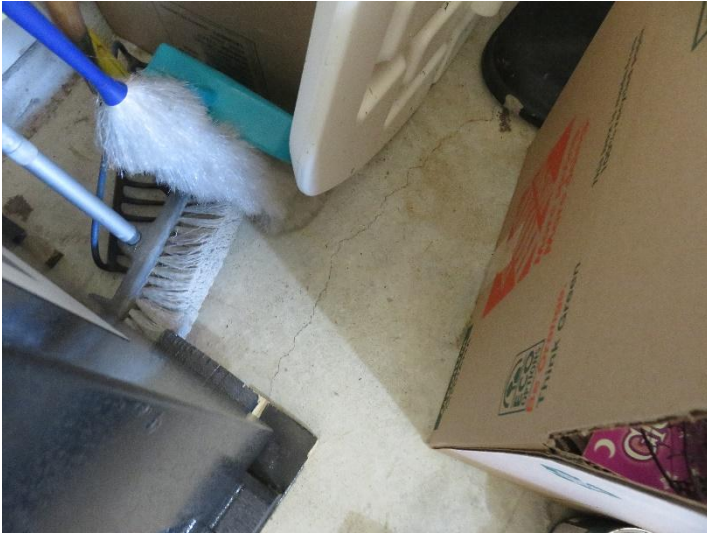
Example at the right rear floor

- The garage floor displays crack(s).

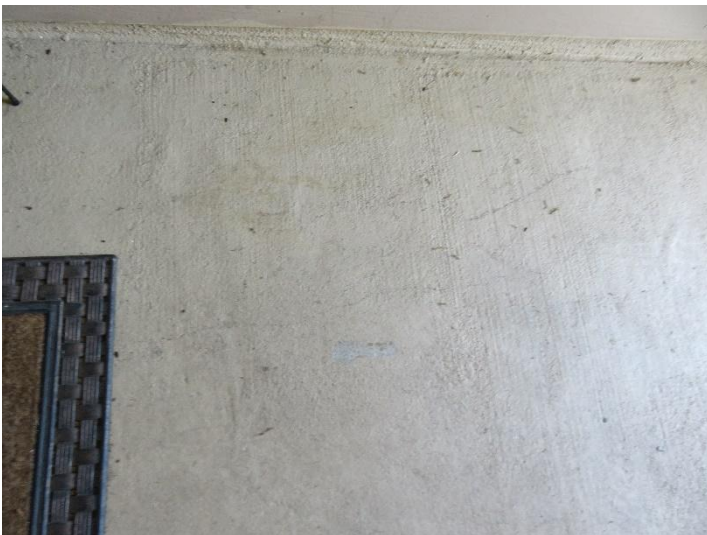
- The front porch displays crack(s).

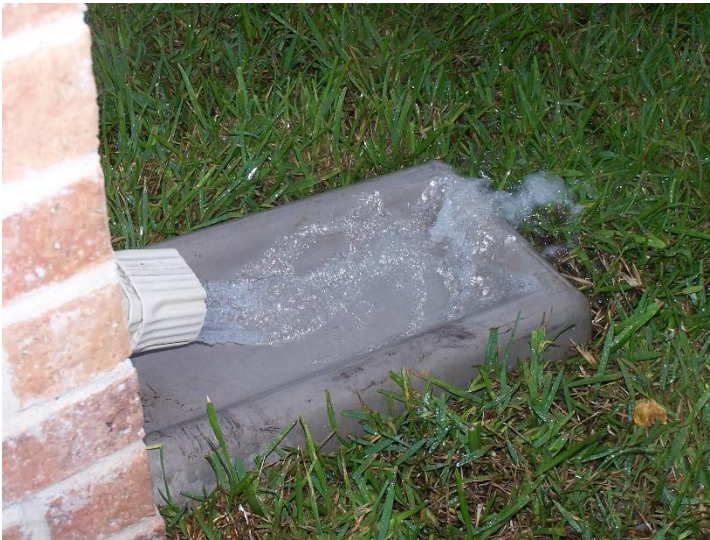
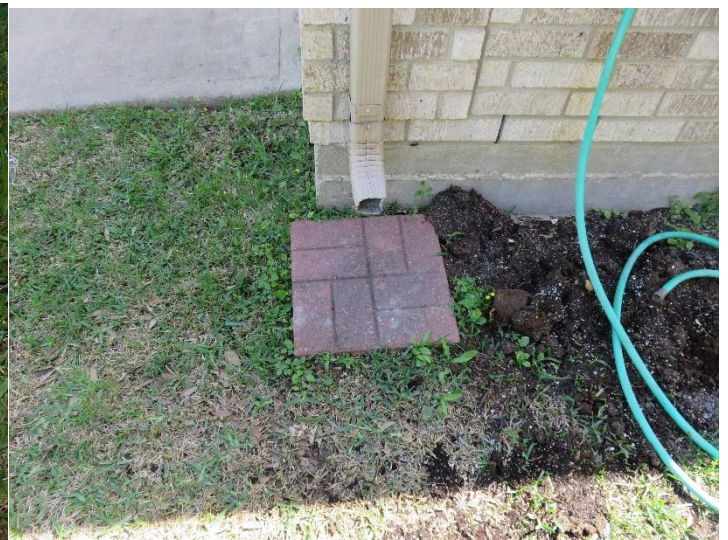
Example of a downspout splash back in action and current installation example(s):

- Downspout splash backs should be installed at the delivery point of each rain downspout. Splash backs should be positioned so that the high side or “block” is positioned away from the home and not against the foundation. They prevent rushing water from eroding the soil and provide an increased directional flow of water away from the home and foundation.

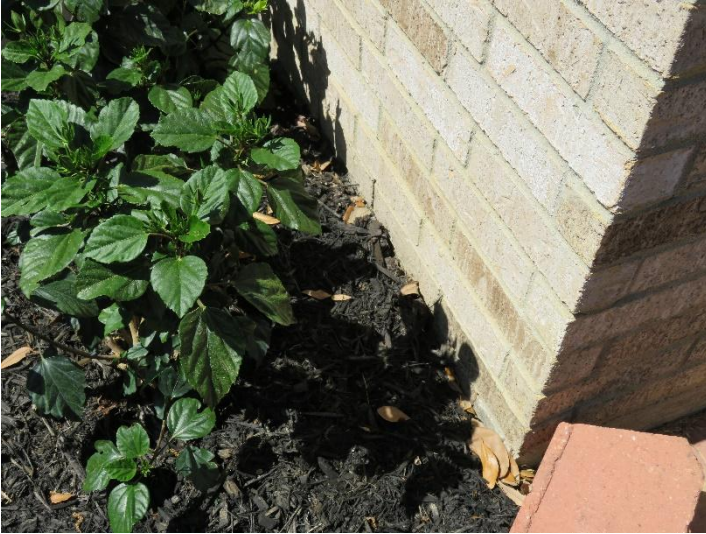
- At the left rear corner of the home mulch and ground materials are too high in relation to the first row of bricks and weep holes at the brick ledge. The opportunity for water to enter these areas and the potential for bug and insect infestation is increased with this condition. There should always be at least 4" of visible foundation to allow for foundation inspection and to promote proper drainage with proper slope away from the home and foundation.

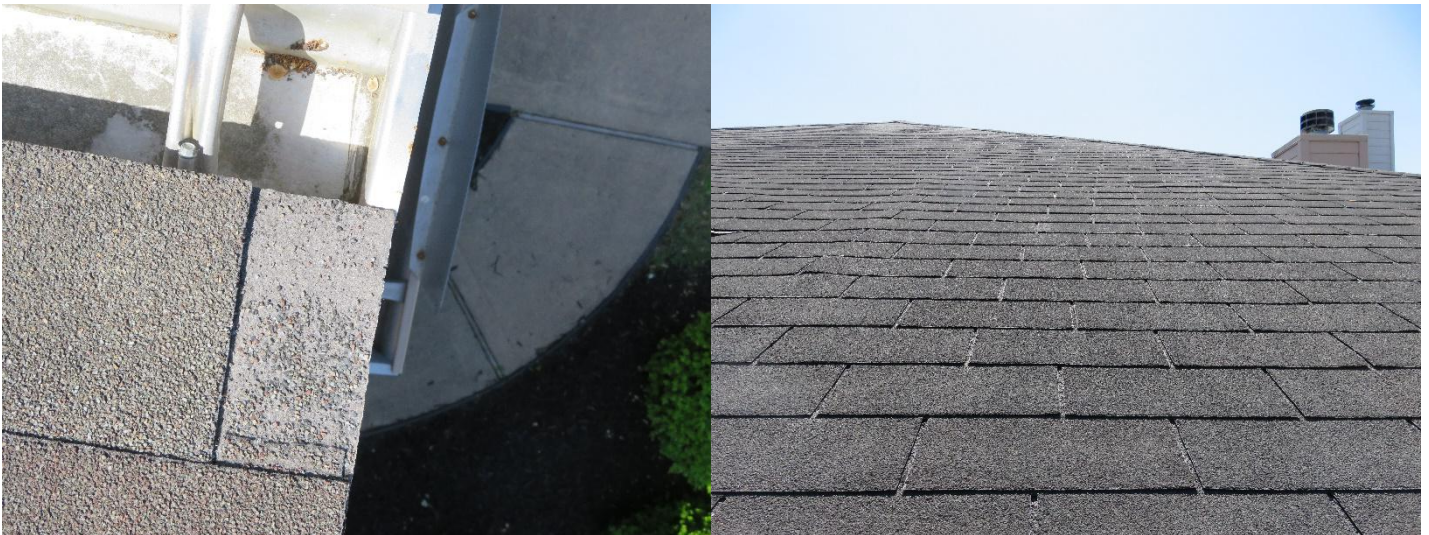
#### Examples

- The roof surface appears to be original to the home. Generally, roof surfaces have a life span of 12 – 15 years. This roof is approaching this milestone. Wear and erosion of shingles is noted.

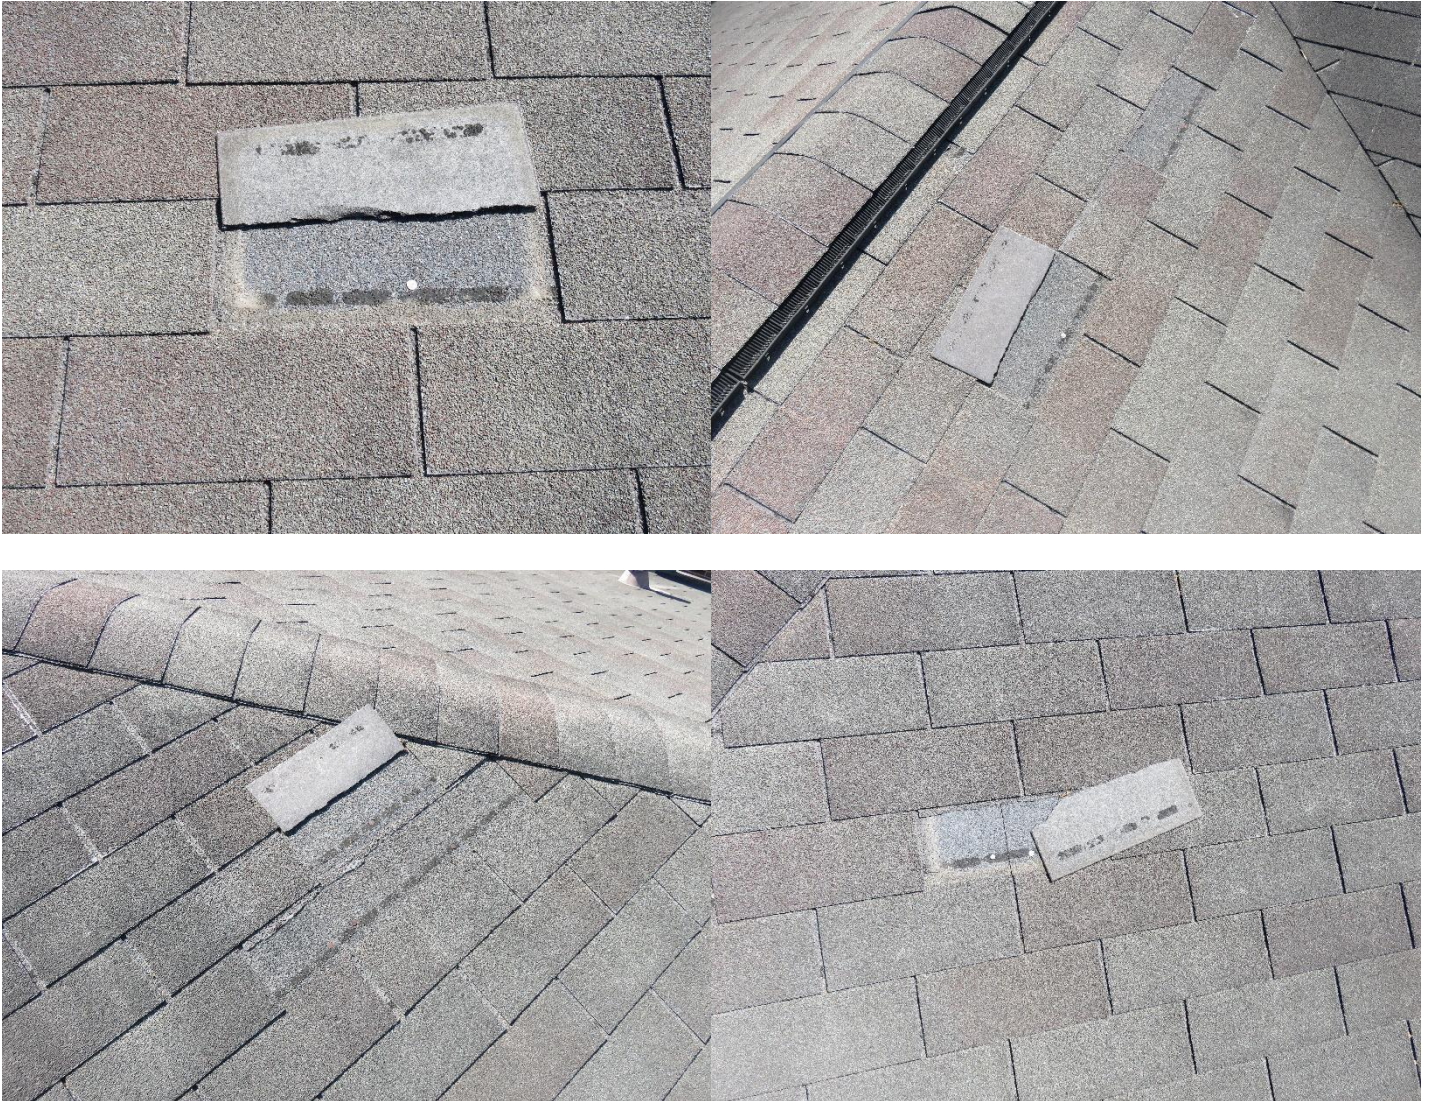
Examples

- Several areas of the roof surface display shingles that have been replaced/folded over.

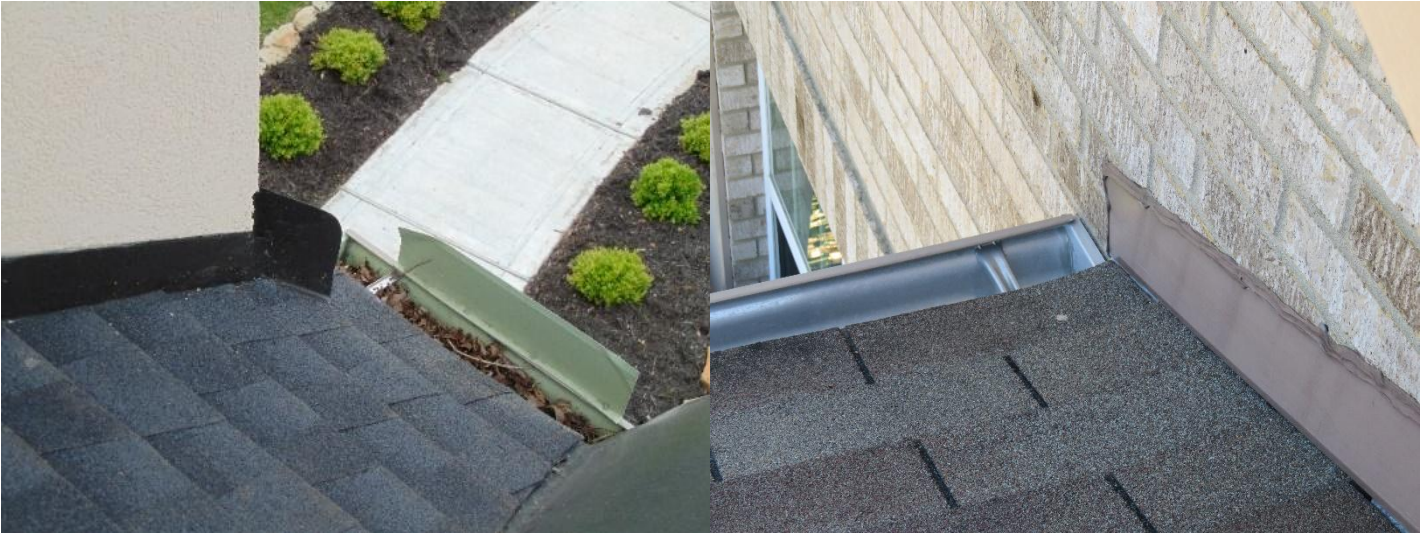
Example and current installation example at the front of the home lacking this flashing

- Kick-out flashing is required at the lower run of rain gutters to divert water away from the wall at the rain gutter/end of the roof.

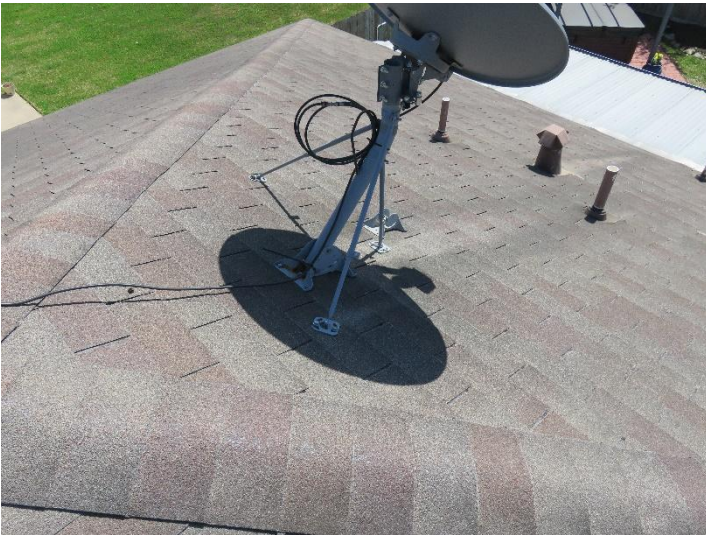
- Roof mounted equipment with penetration through the roof deck should be monitored during use and removed if leakage is detected. A manufactured holder is available for installation of the dish hardware. It is said to reduce the potential for leakage through the roof.

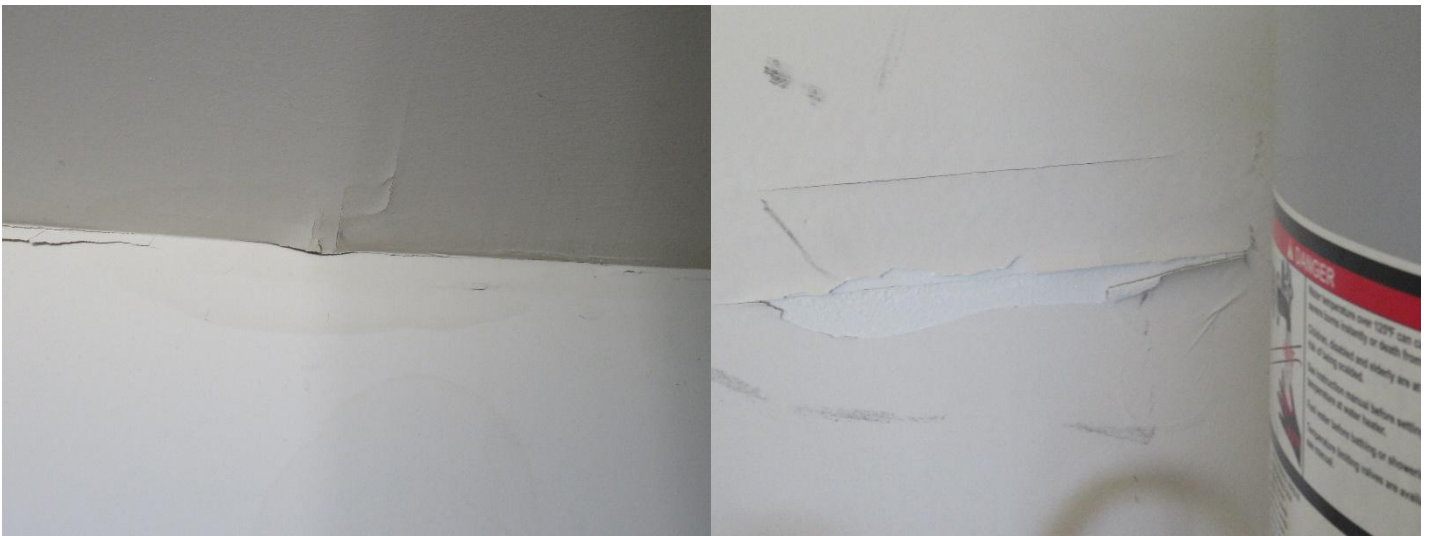
- In the garage adjacent to the water heater, an area of ceiling and wall has been affected by water penetration from an unknown source.

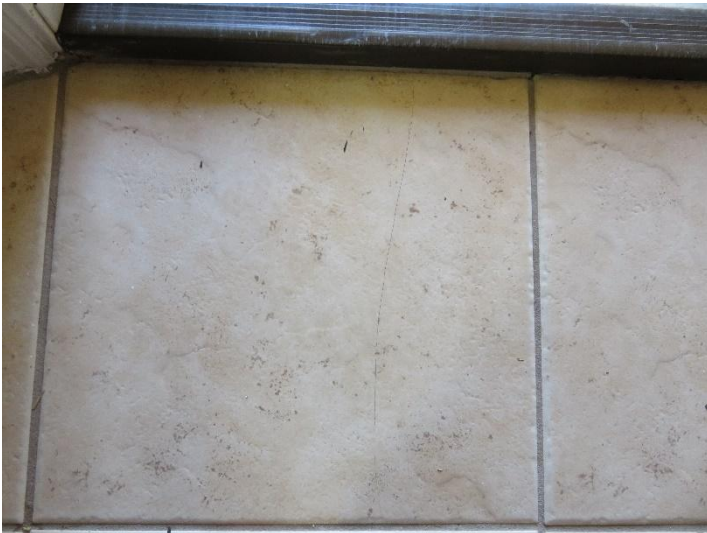
- At the front entry door a floor tiles is cracked.

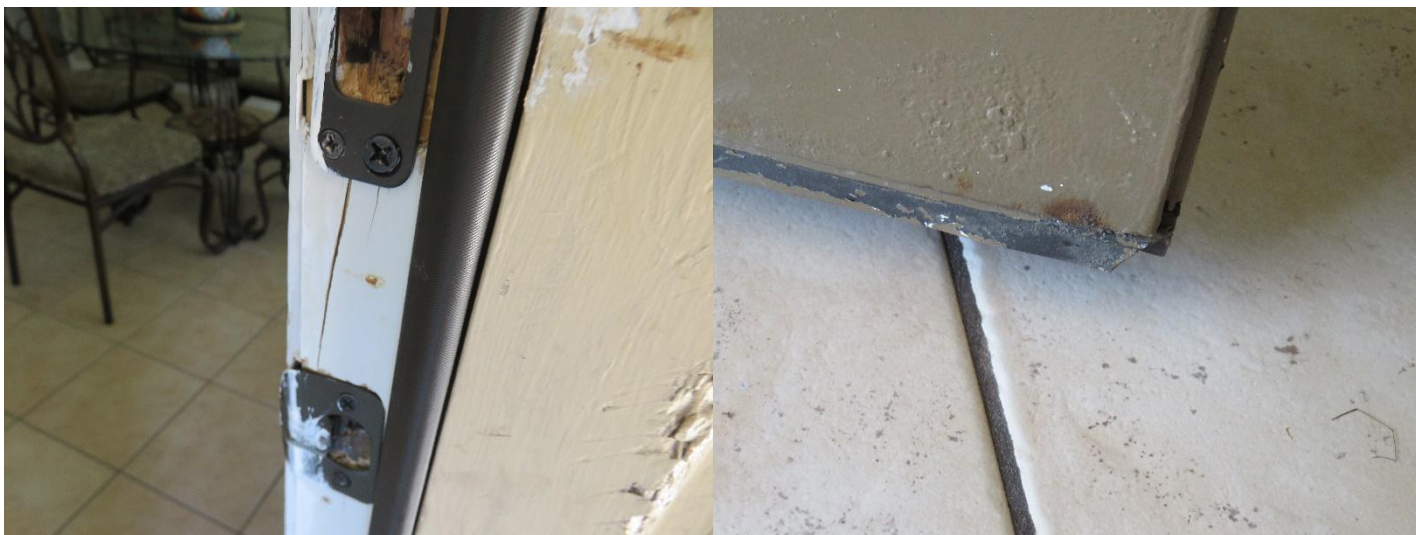
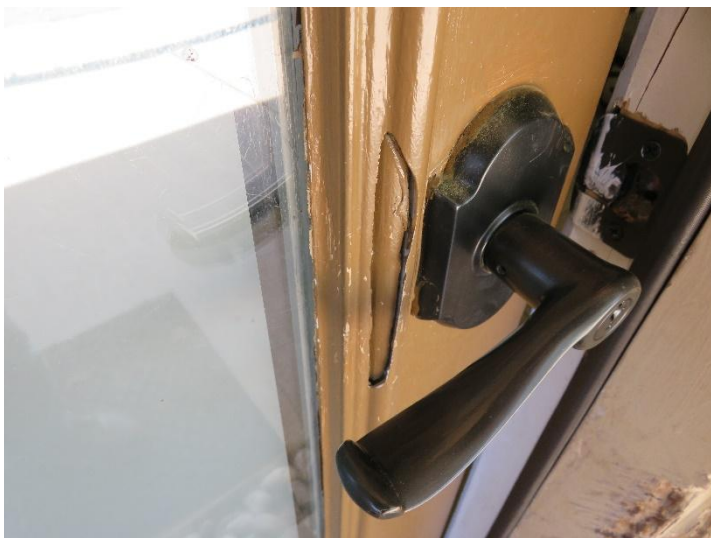
- The rear entry door displays a cracked door jamb, rust, damaged trim and damaged exterior adornment.

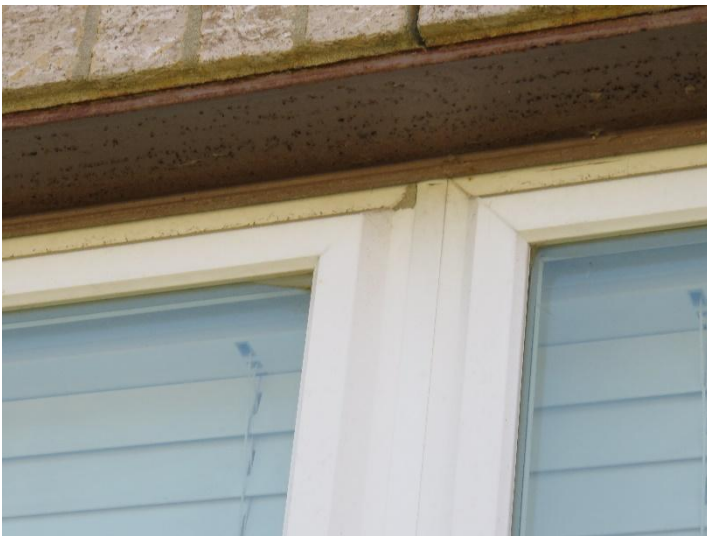
Example of rust at the front left window

- Windows with brick walls supported by steel lintels will rust if condensation/water is allowed to accumulate or penetrate behind the wall of brick. The top of the lintel should be installed with flashing between the bottom of the first row of brick and the lintel. **[IRC - 703.7.5]**. It could not be ascertained to what degree, if any, flashing is installed in this manner. Weep holes can be provided by drilling/removing a portion of the mortar between bricks at the top of the lintel. Weep holes are required to be 3/16" in width and installed in pairs above a window and/or at least within 33" of each other. [IRC - 703.7.6]. Already rusting lintels should be scraped and painted with a rust preventing paint.

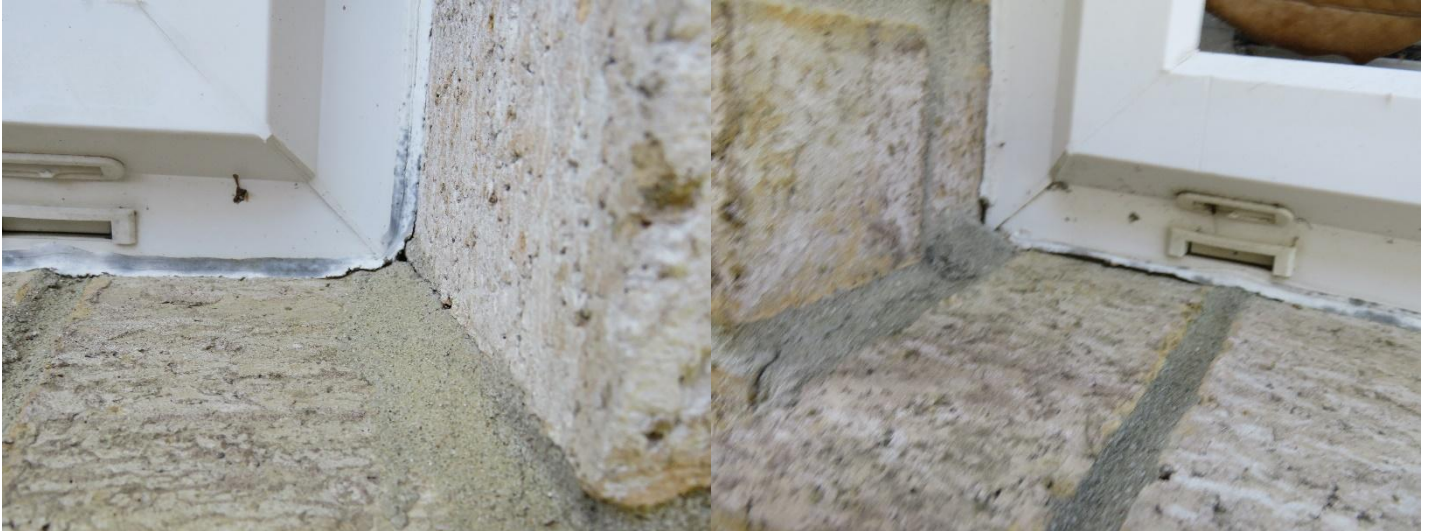
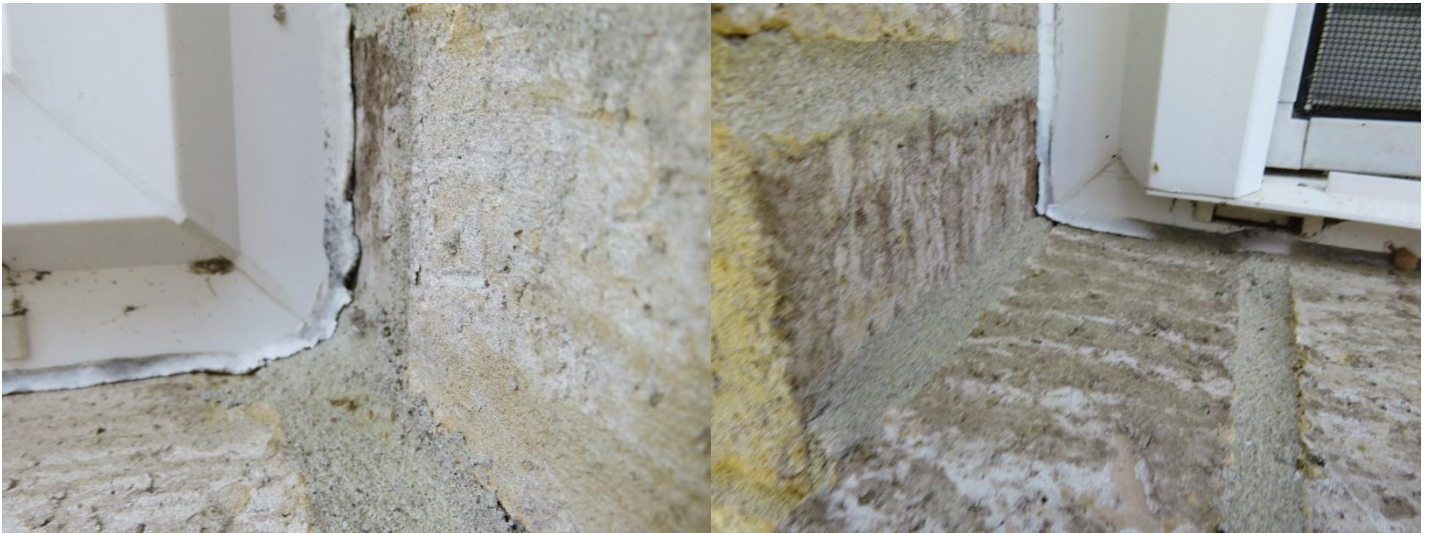
Examples

- All exterior window sills should be filled/caulked to assist in preventing water leakage into the home.

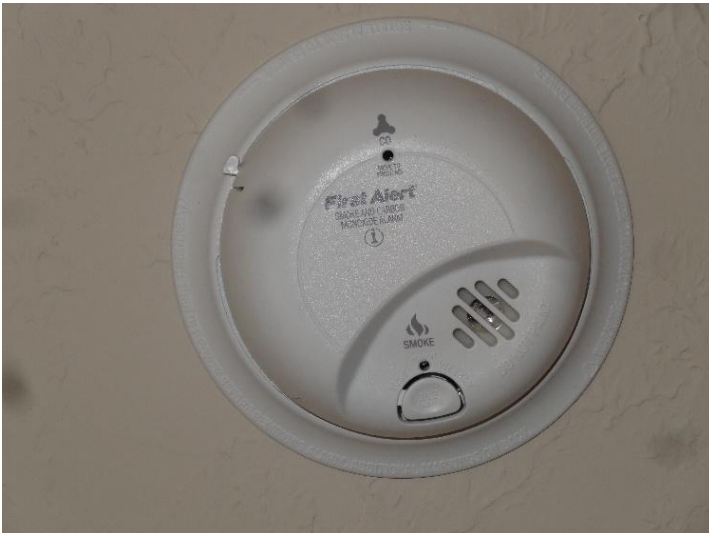
Example

- Carbon Monoxide detectors provide advance warning of this colorless, odorless gas just as smoke detectors provide advance warning of smoke and combustible conditions. Placement of these detectors in the hallway of the home immediately outside each bedroom, on each floor and in accordance with manufacturer recommendations is a required fire safety precaution. IRC {315.1}. Inclusion in the smoke detection system is required.

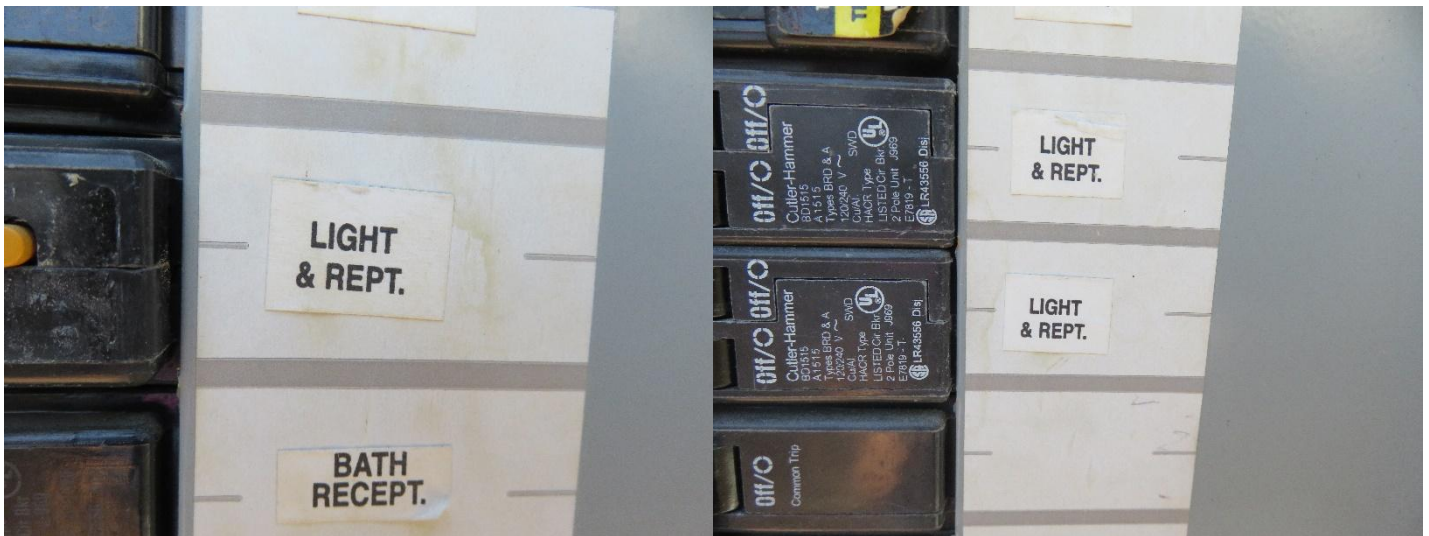
- Individual circuit breakers for the home are not labeled in the service entrance panel for specific areas, fixtures and/or appliance as required. General labeling is prohibited.

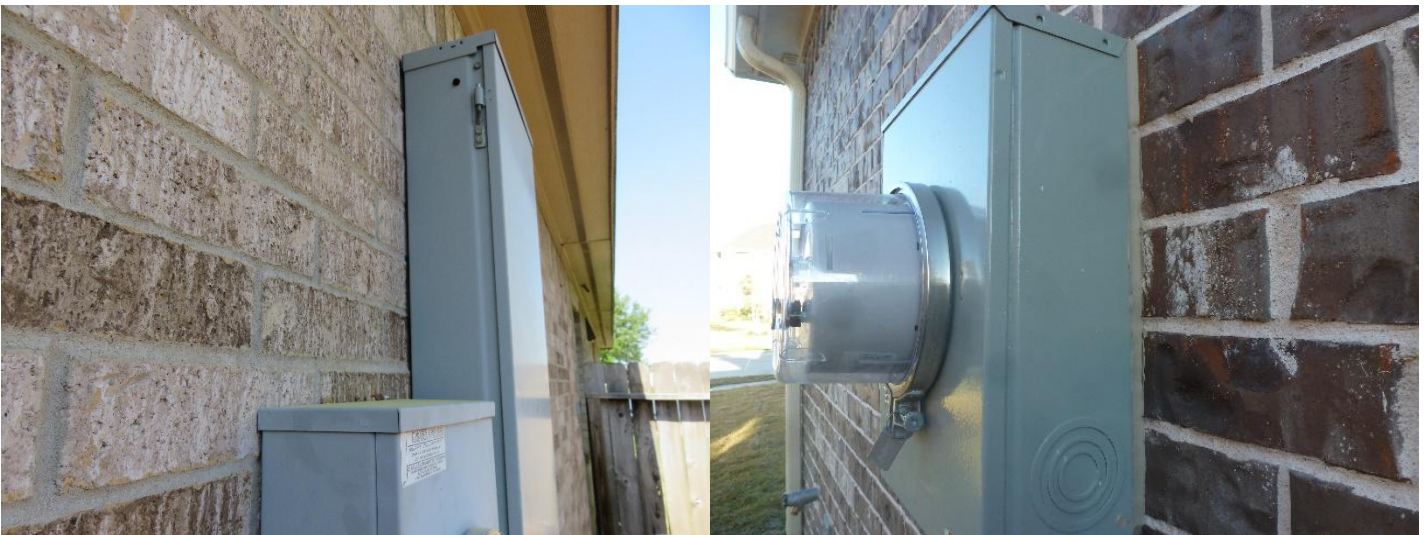
Current installation and example of recommended caulking

- The electric panel box(s) should be caulked around their perimeter and between panels to assist in preventing water from accumulating behind the box at the porous wall substrate creating the potential for wall damage.

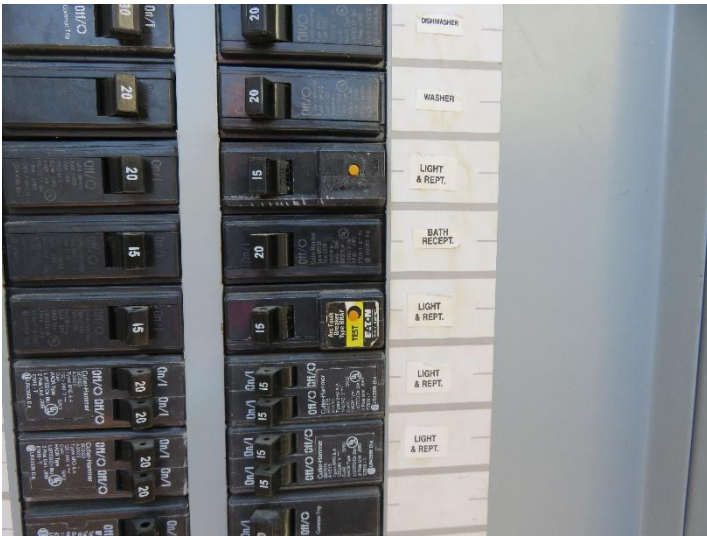
- The smoke detectors are not labeled in the panel.

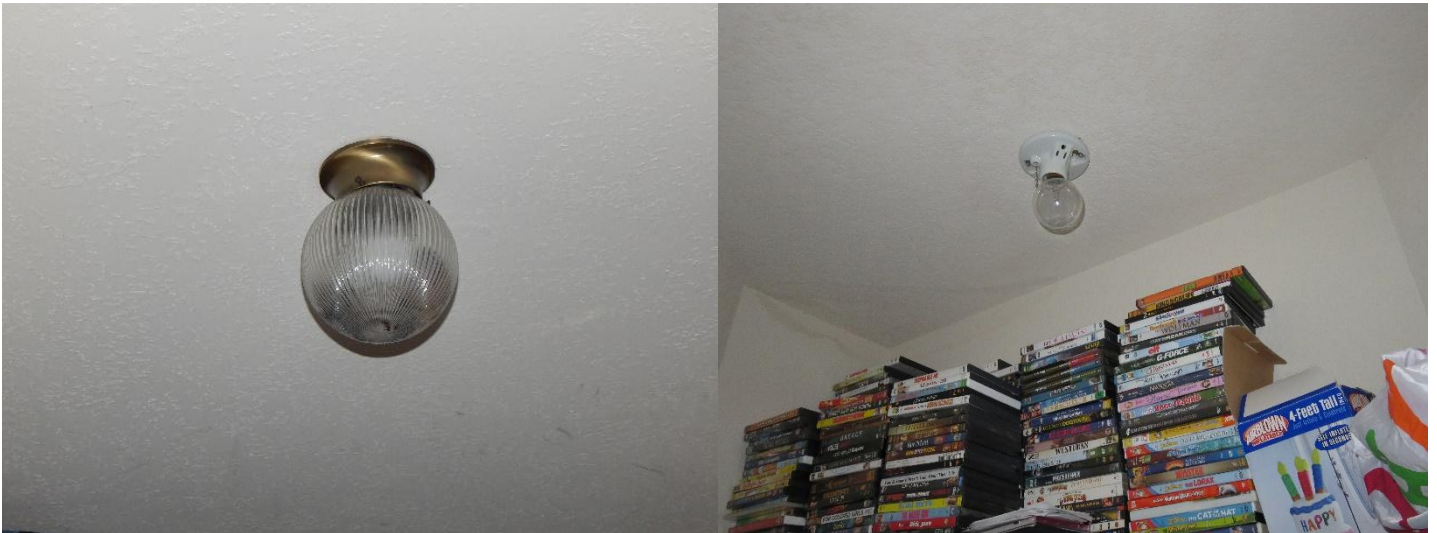
Example of a globe and current installation example in the bedroom hallway closet

- Closet lighting displays unprotected/incandescent bulbs that are unprotected by a globe. Should combustible storage be placed within 12" of one of the bulbs, a fire could ensue. These lighting fixtures should be replaced by fixtures having a globe surrounding the bulb.

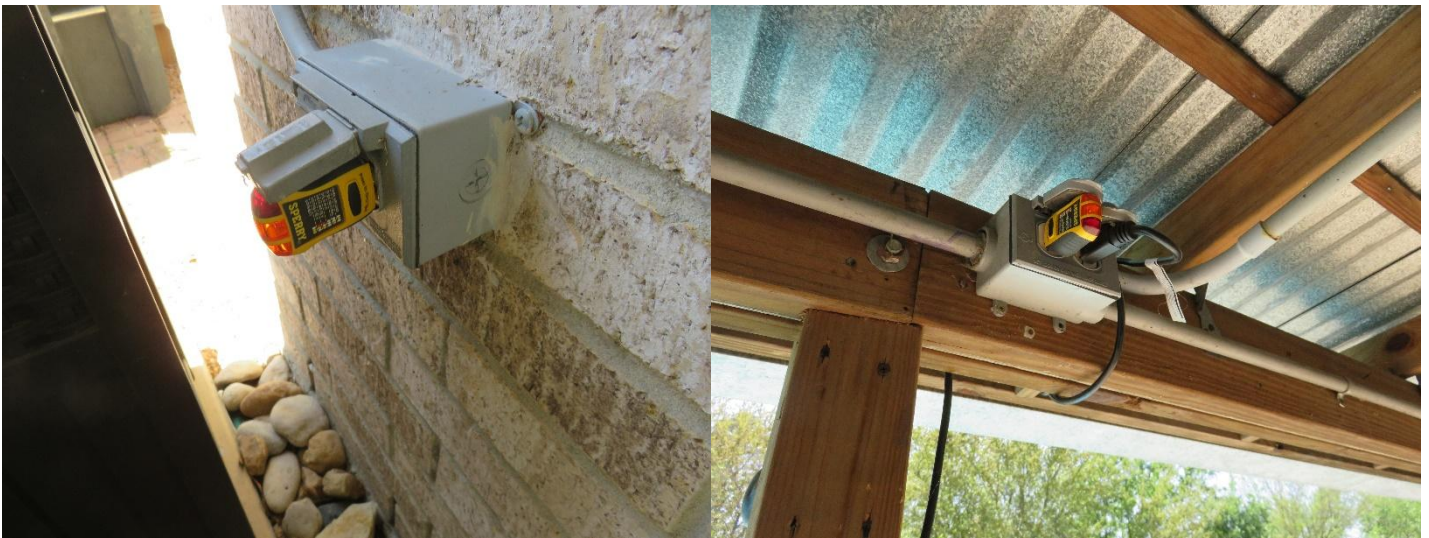
- All garage outlets are required to be GFCI safety protected. This includes the garage door opener(s)(2008).
- All exterior outlets are required to be GFCI safety protected. Outlets at the rear wall of the home and along the framing of the roof covering are required to be GFCI safety protected. They did not respond to GFCI testing.

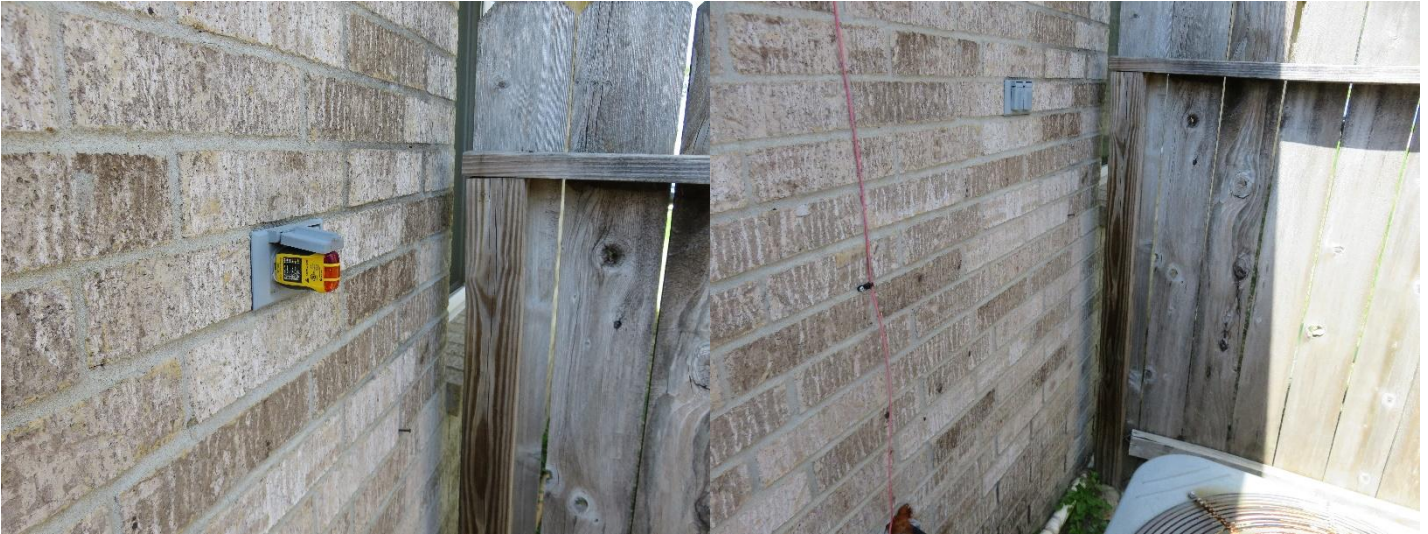
- At the AC unit, the outlet lacked power and is required to be GFCI protected.

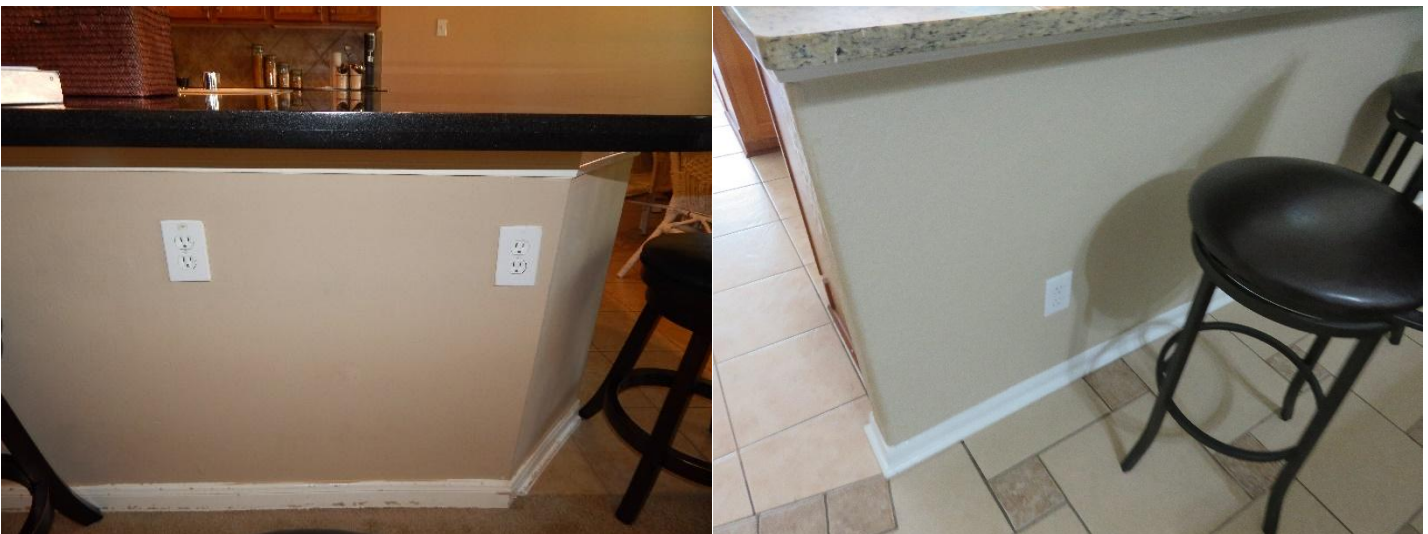
Required and current installation

- All 15 – 20 AMP kitchen countertop outlets are required to be GFCI safety rated/protected. This includes the dishwasher and disposal outlets, if accessible - IRC{210.8(D)} 9/2014
- The outlet(s) on the family room side/dining side of the kitchen sink countertop are required to be GFCI safety rated and no lower than 12” beneath the countertop for safety of crawling toddlers and smaller children. (IRC 3901.4.5X)

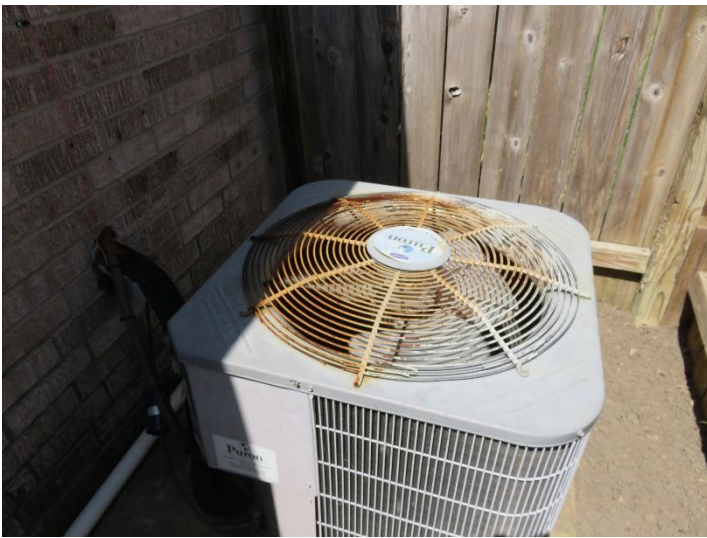
- The unit appears to be the original to the home. It is rusty. Generally, the unit has a life of 12 – 15 years.

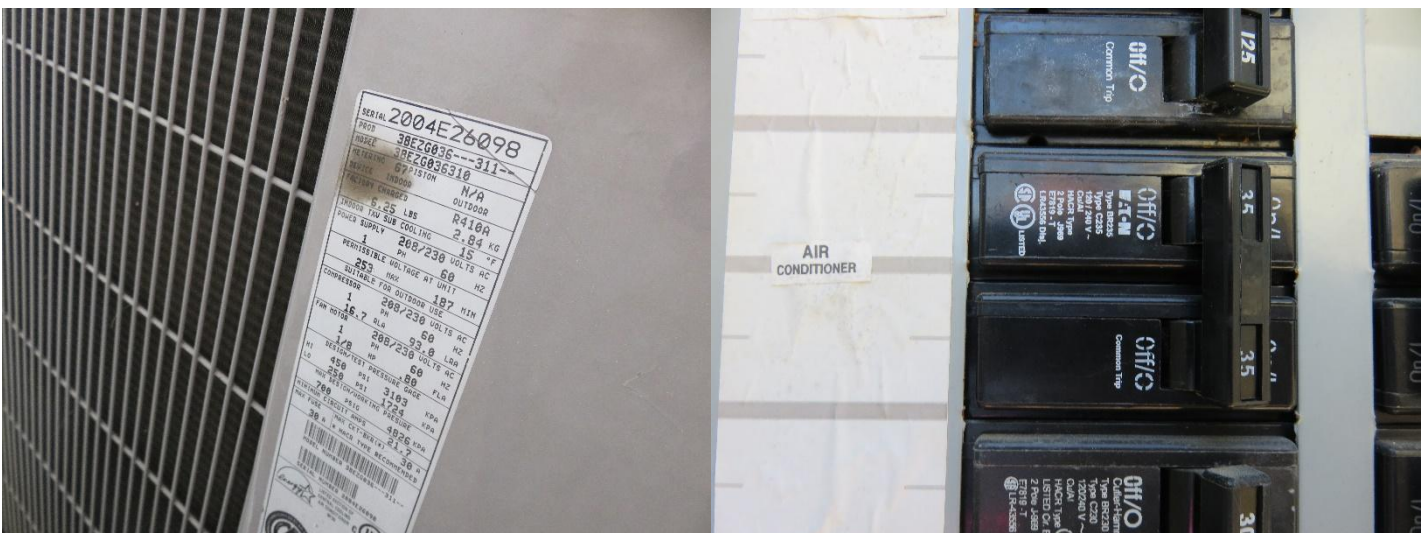
- The AC condensing unit documents that the maximum circuit breaker amperage to be used is 30 AMP. The breaker in the main service panel for this unit indicates that there is a 35 AMP breaker in place.

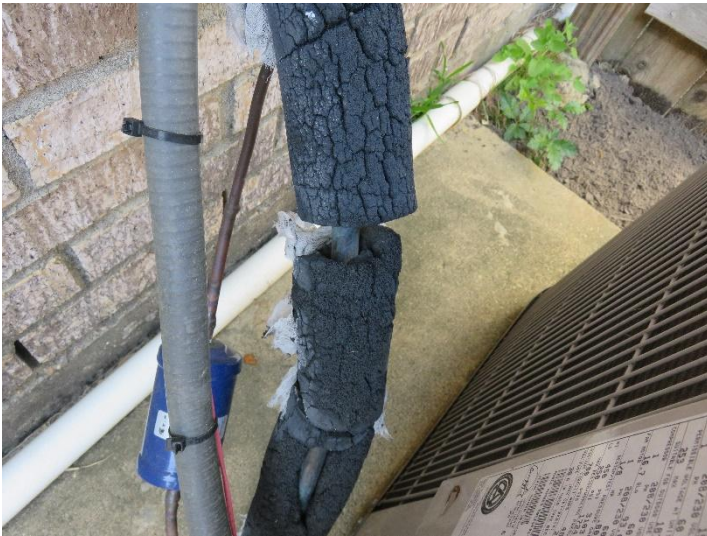
- Insulation at the unit suction line is in poor condition and should be replaced.

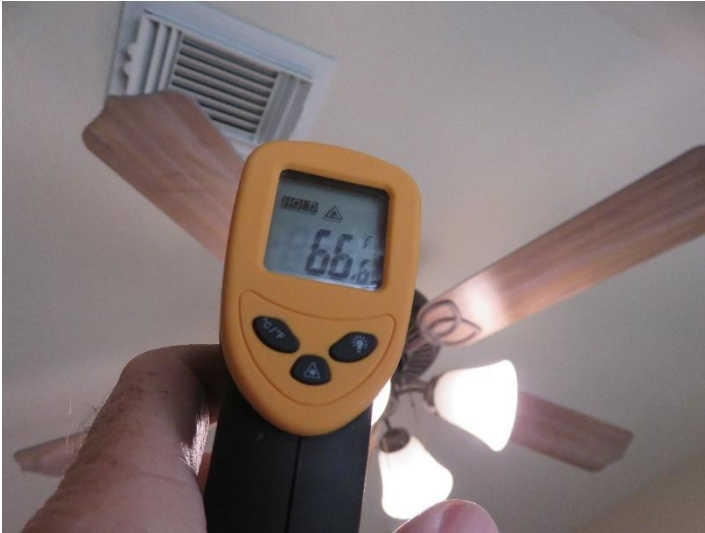
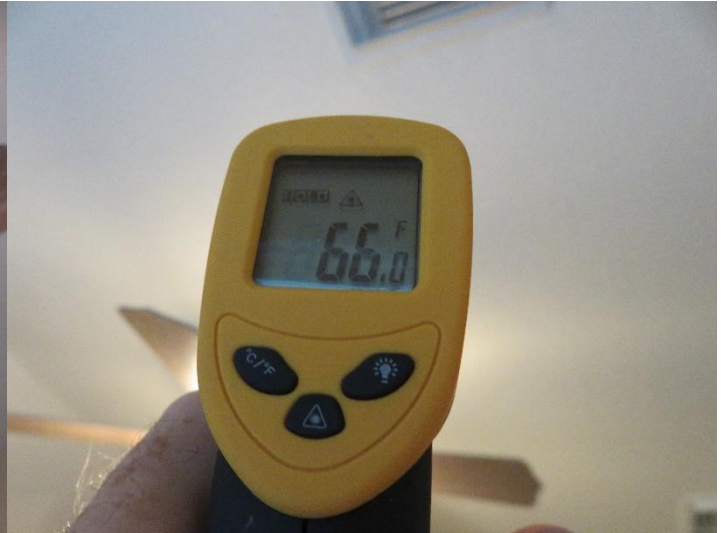
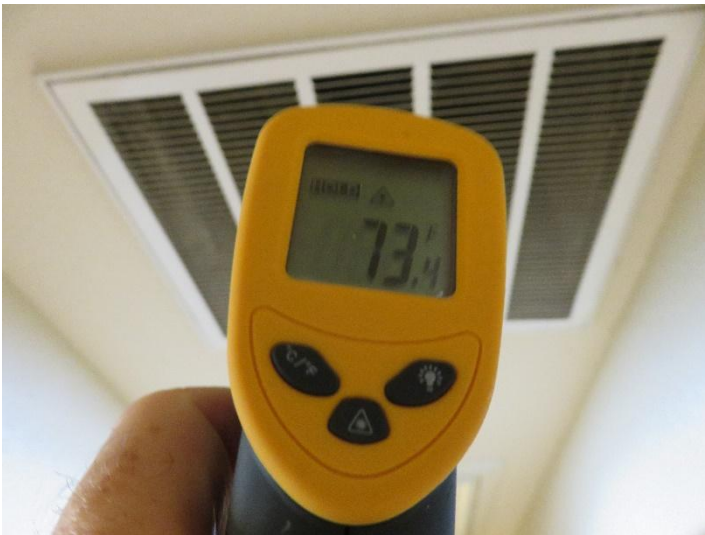
- The ductwork of the left side of the home appears to be obstructed with inadequate chilled air flow as compared to the kitchen and Master suite.

(7°F of temperature differential)

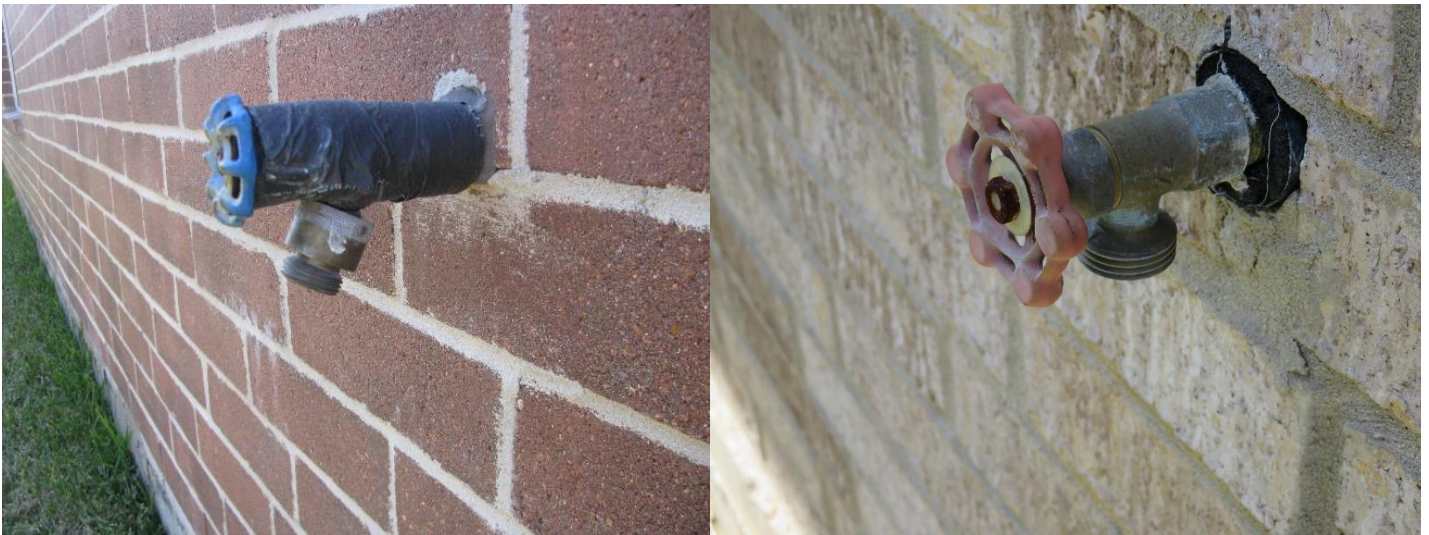
Example of an anti-siphon apparatus and current installation(s)

- All exterior hose bibs should be equipped with anti-siphon appendages that act to prevent gray water from being drawn back into the fresh water supply of the home.

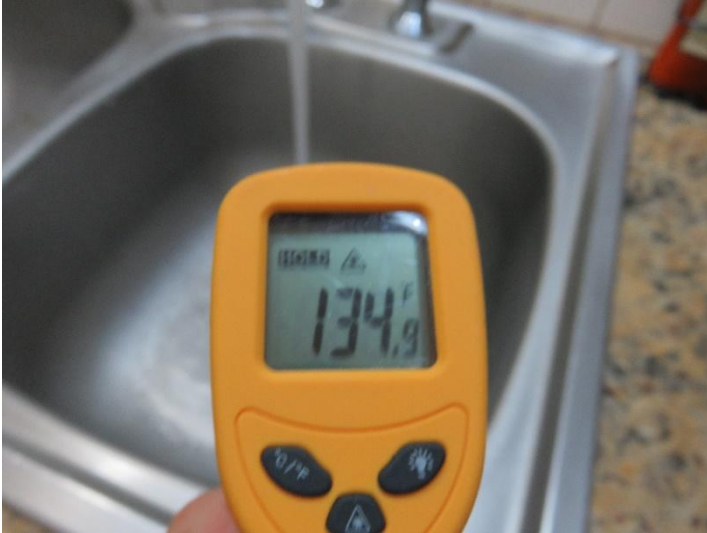
- The water temperature as recorded at the kitchen sink is too hot. Temperatures in excess of 120°F can cause severe burns and scalding.
