# PROPERTY INSPECTION REPORT

## “AROUND THE HOUSE” HOME INSPECTIONS

By: **David J. Stiles Inspector Lic. #7308** **3/19/2019**

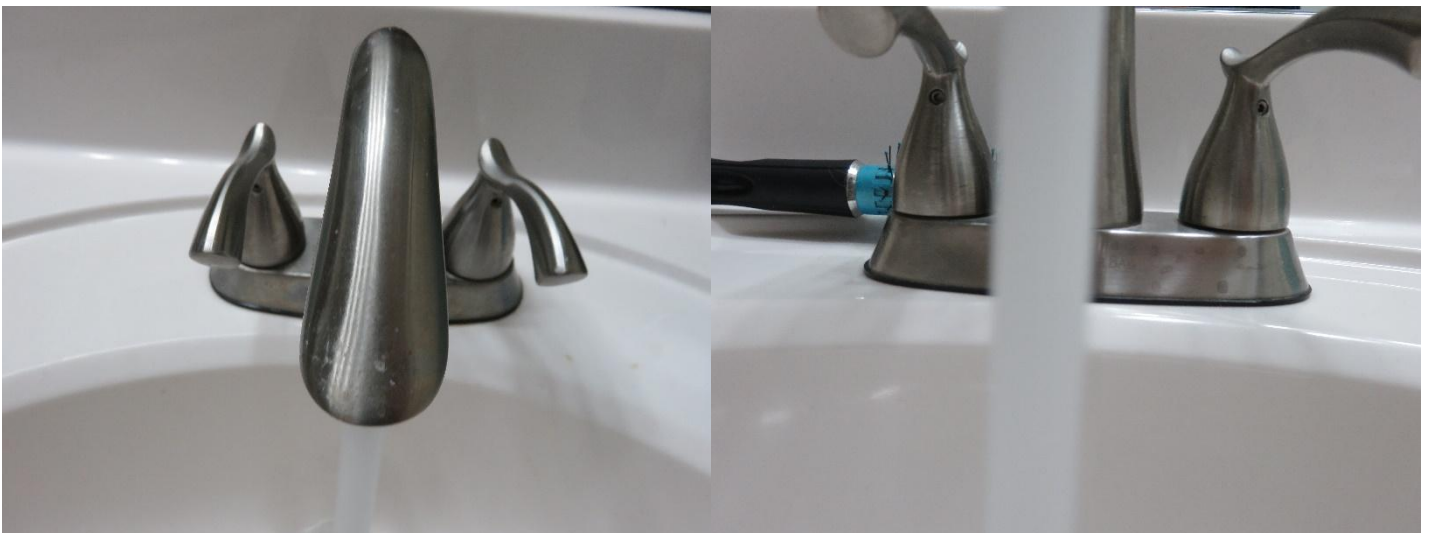
Current installation examples and example of labeling

- Toilets should be secure at the floor and should be caulked around their edges against the floor to prevent/deter water leakage. The guest bathroom toilet lacks these qualities.
- All water supply faucets should be marked by color coding, engraving or other means to identify each handle for water temperature orientation. This includes the washing machine faucets handles.

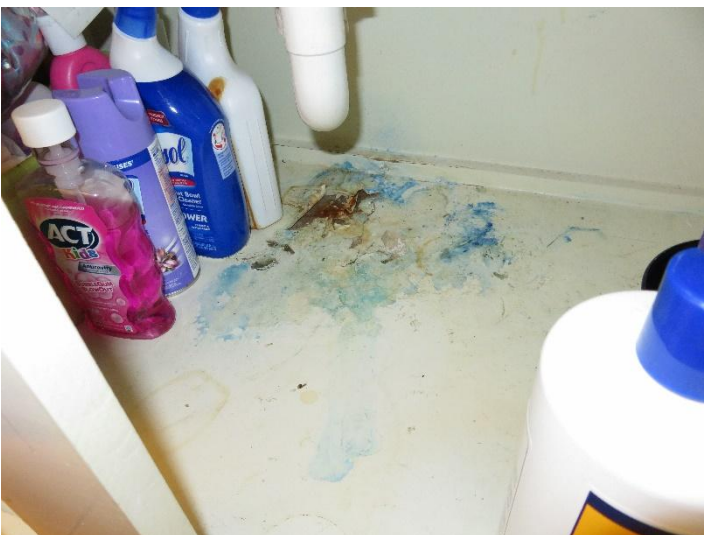
- There appeared to be a leak at a time in the cabinet of the guest bathroom.

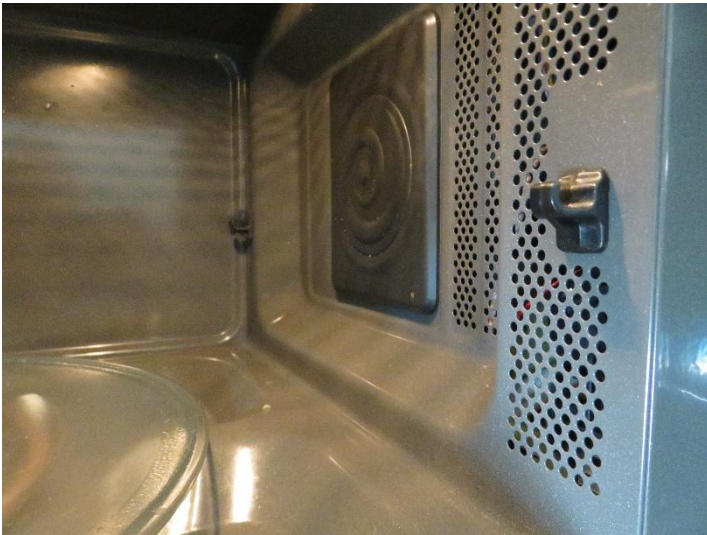
- The interior dish rack has been removed.

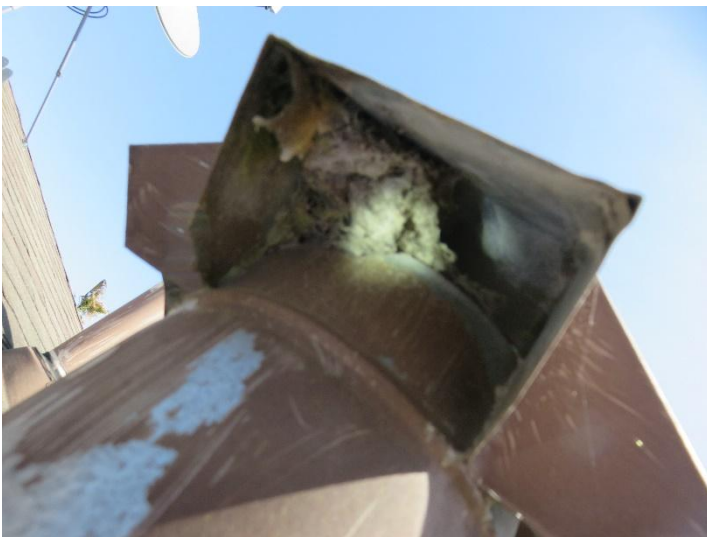
- The hood and ductwork are congested with lint creating a significant fire hazard.

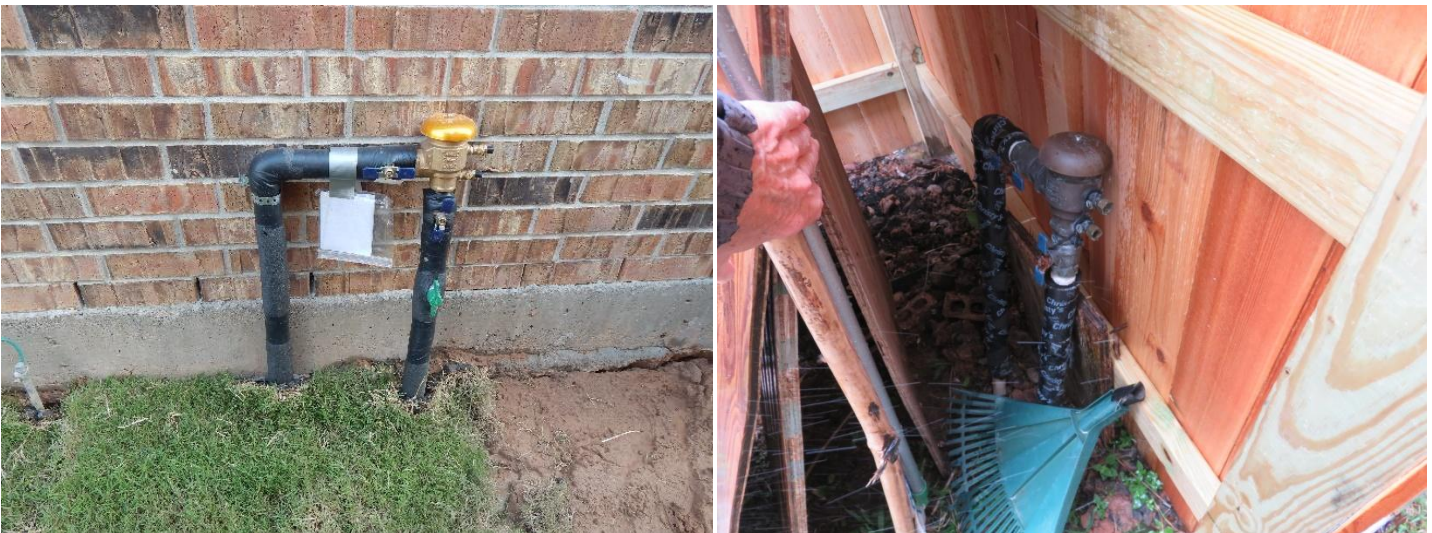
Example and current installation

- The backflow preventer should have an **intermediate shut off valve** on the supply side.

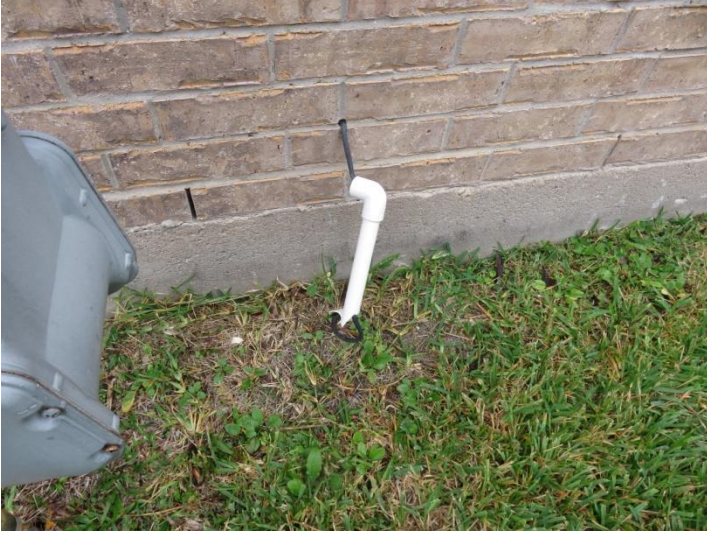
- Conduit installed to protect the wiring of the sprinkler system is damaged, separated exposing the wires and creating an opening where water and insect penetration can penetrate into the home.

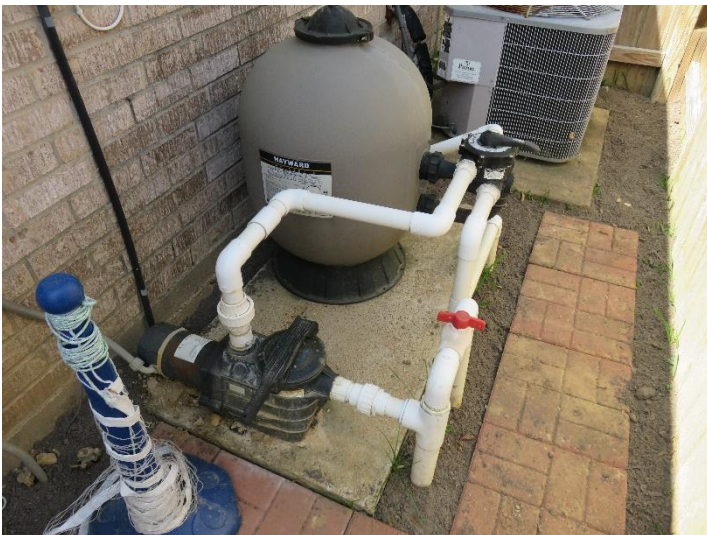
- Windows and doors that exit from the home to the pool area are required to be equipped with audible warning devices such as an alarm that lasts at least 30 seconds that is activated whenever a door or window leading to the pool area is opened. Safety of small children entering the area unattended is the reason for this installation.
- Due to the presence of the swimming pool in the backyard, the fence gate should be 6' in height and equipped with a self-closing, self-locking device on the inside of the fence. This is done for safety precautions relevant to children and others wandering the neighborhood and accidentally entering the pool area unaccompanied.
- Plastic plumbing pipes at the pool equipment are required to be painted to protect it from sunlight/ultraviolet light that will cause degradation of the piping.

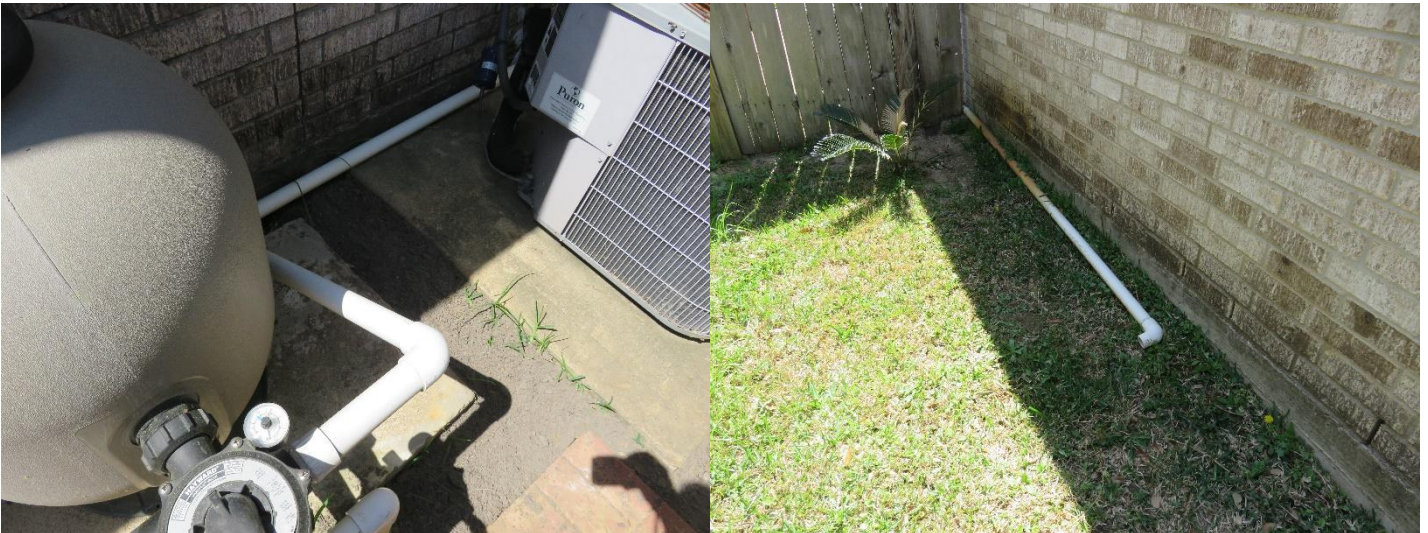
- The pool drain is required to terminate in a sanitary drain/system. Draining pool water to the street or in the current installation to the left side lawn is prohibited.

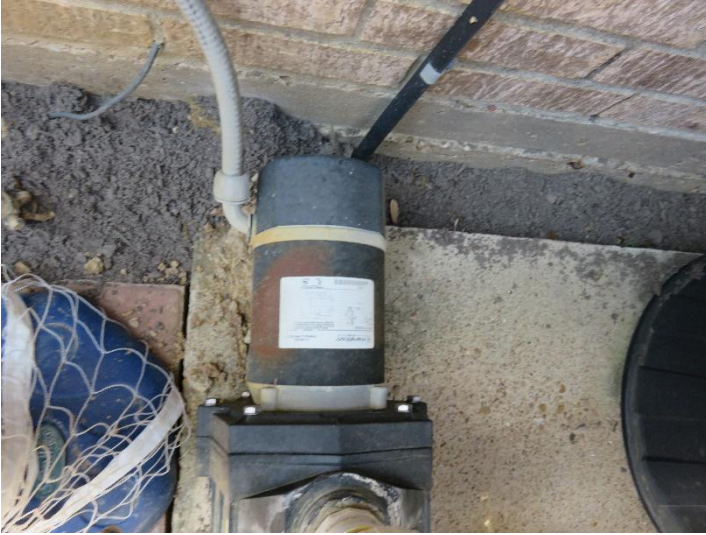
- The pump motor (all electrical mechanical equipment) does not appear to be grounded to earth as required.

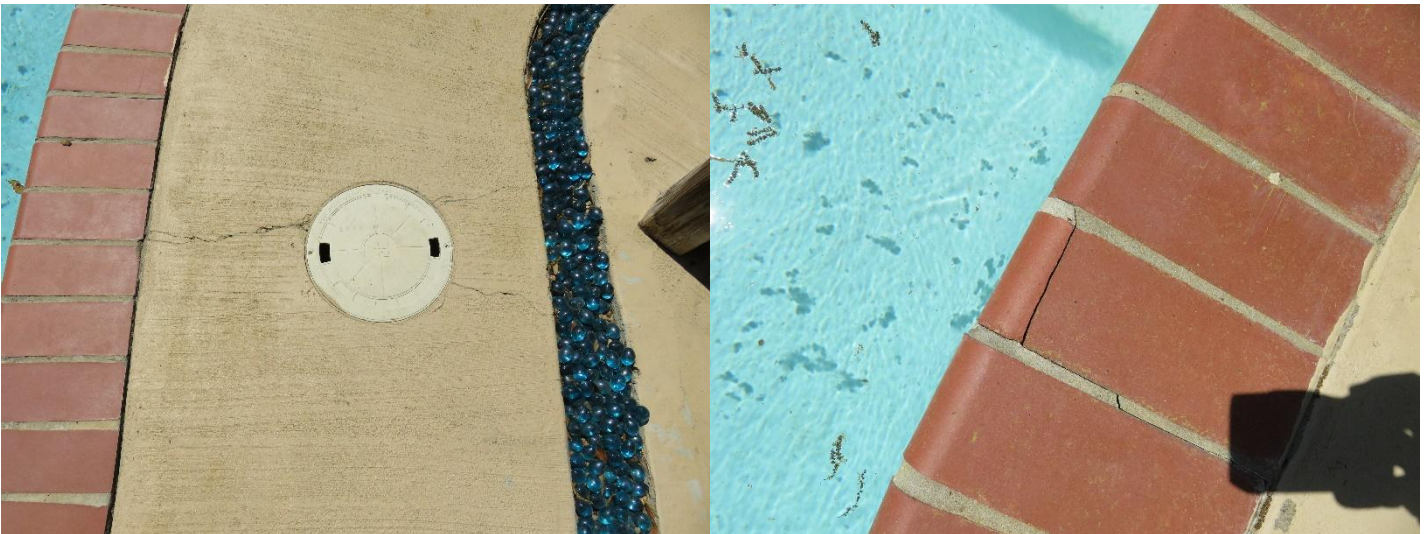
- The pool deck displays several cracks.

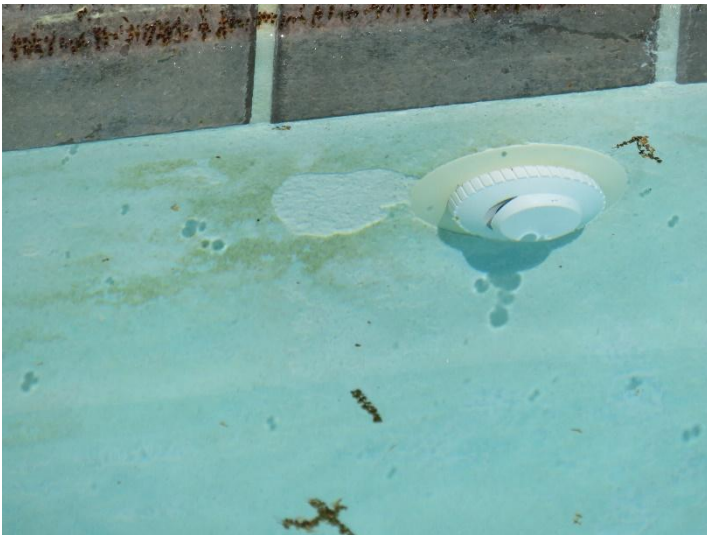
Example at the front right wall

- Some areas of the pool surface displays wear/deterioration.
