# PROPERTY INSPECTION REPORT

## “AROUND THE HOUSE” HOME INSPECTIONS

By: Randy Stiles      Inspector Lic. #21519      DATE

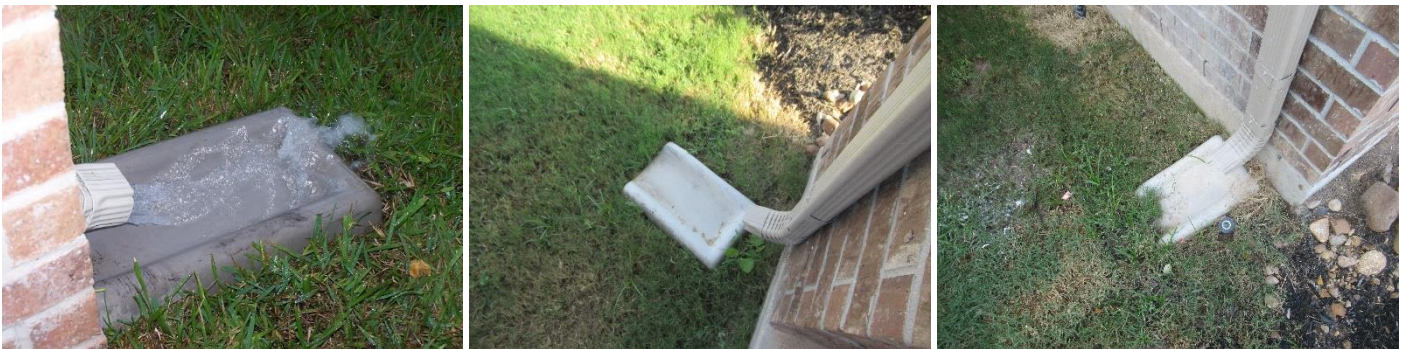
- Downspout splash backs should be installed at the delivery point of each rain downspout. Splash backs should be positioned so that the high side or “block” is positioned away from the home and not against the foundation. They prevent rushing water from eroding the soil and provide an increased directional flow of water away from the home and foundation.

Example of a downspout splash back in action and current installation(s) (2)

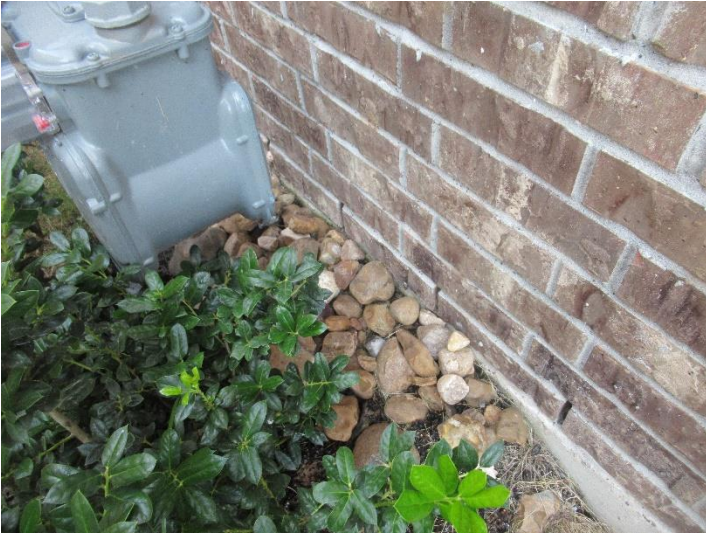
- At the left side of the home mulch and ground materials are too high in relation to the first row of bricks and weep holes at the brick ledge. The opportunity for water to enter these areas and the potential for bug and insect infestation is increased with this condition. There should always be at least 4" of visible foundation to allow for foundation inspection and to promote proper drainage with proper slope away from the home and foundation.

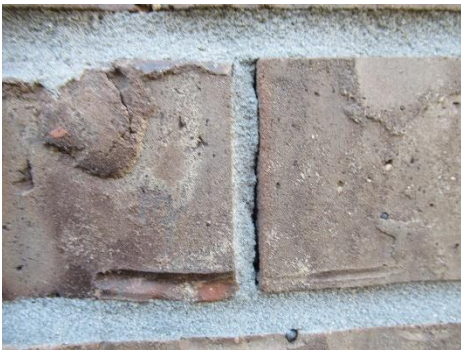
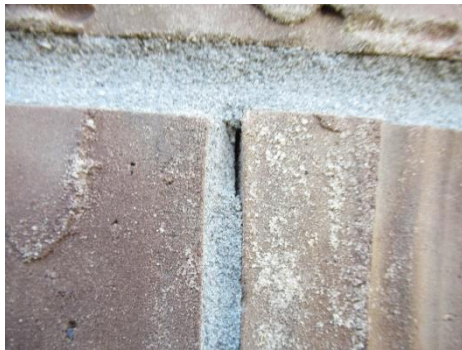
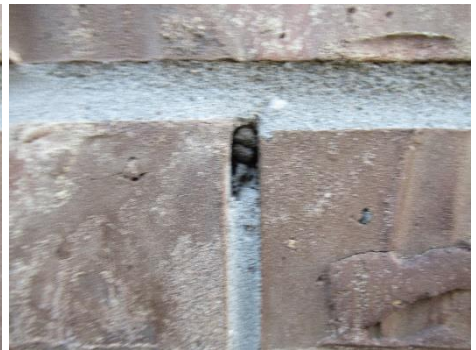
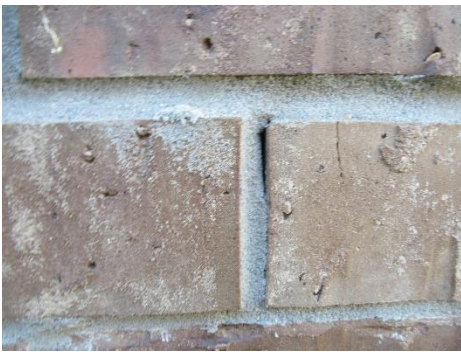
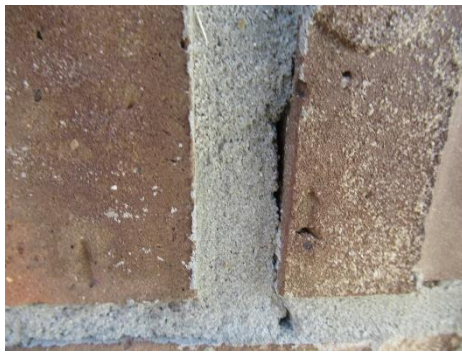
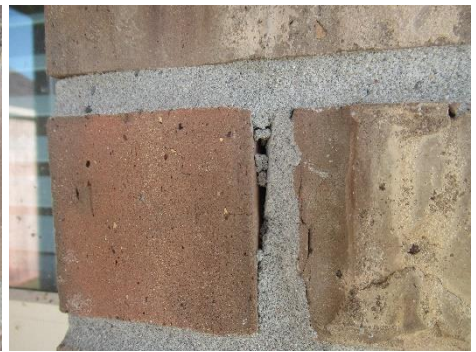
- All exterior openings in walls should be fully sealed.

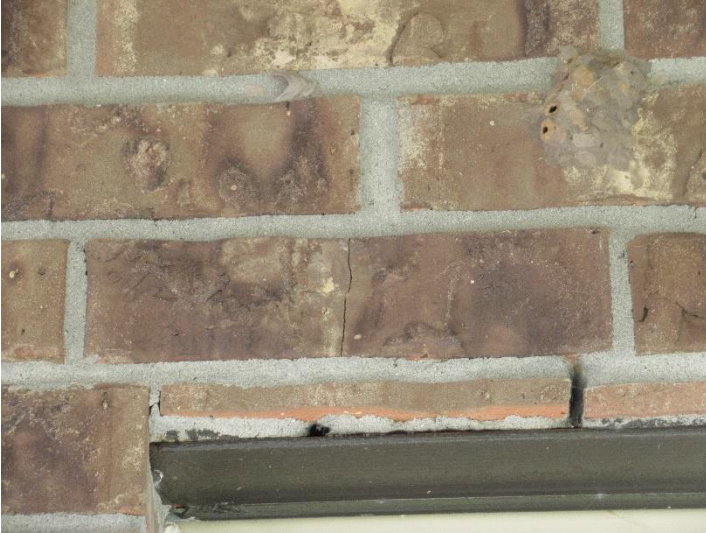
- A cracked brick is present above the center living room window.

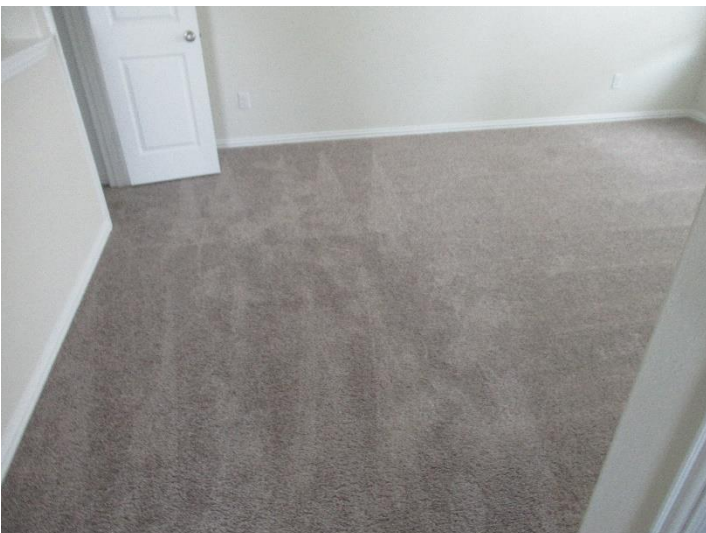
- The subflooring at the upstairs living space is loose and creaks when walked upon.

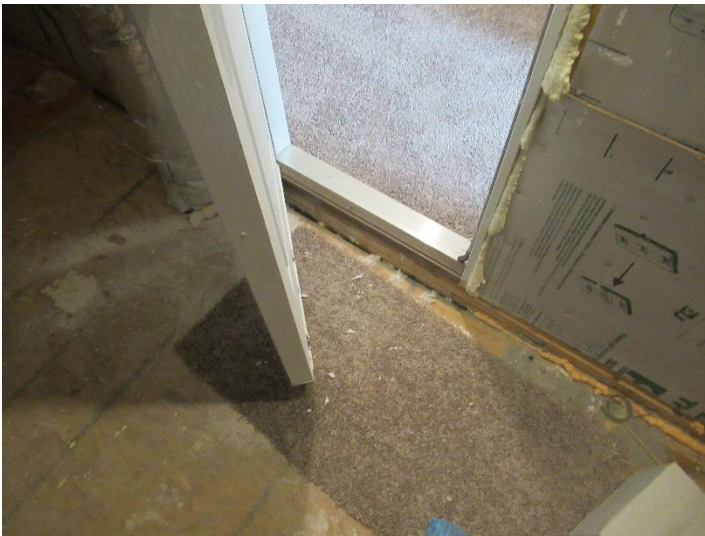
- The door-to-attic is prohibited from opening over a step. This poses a trip hazard.

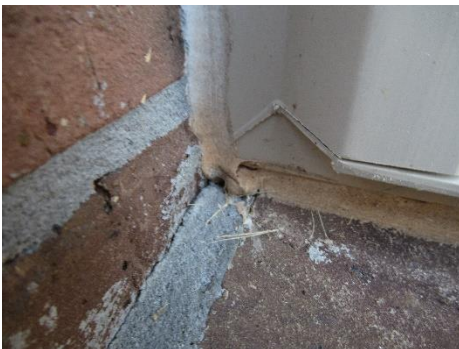
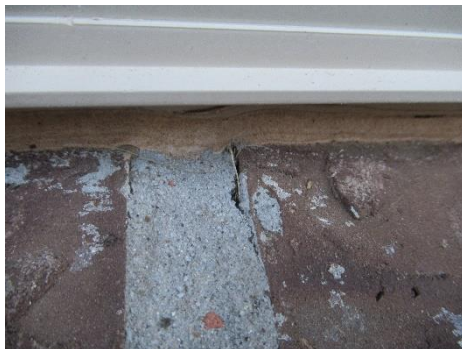
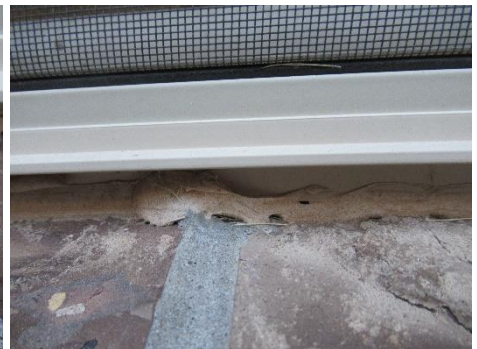
- All windows should be fully caulked/grouted to assist in preventing water penetration into the home.

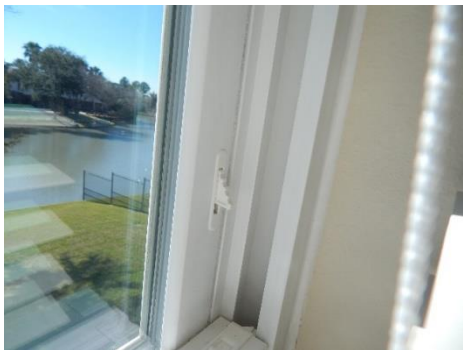
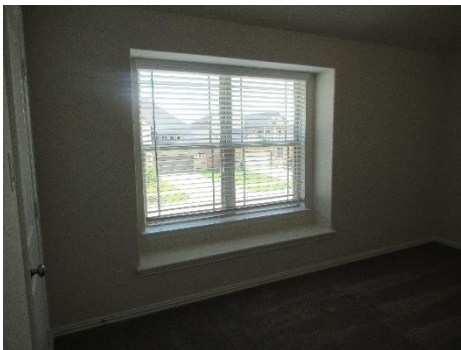
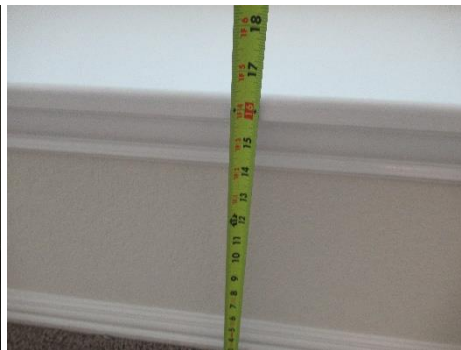
- Windows >72" above the exterior finished grade are required, at sill height, to be a minimum of 24" above the finished floor for child fall safety precautions. IRC {612.2}. The only exceptions include (1) windows that do not open in excess of 4" sphere, (2) windows that are equipped with fall protection devices per ASTM F 2090 and (3) approved window opening limiting devices.

Example of a safety device and current installation(s) (2) at the upstairs front-left bedroom

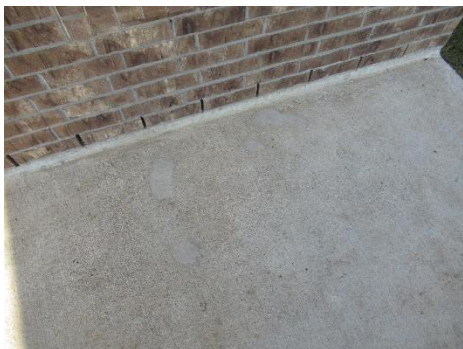
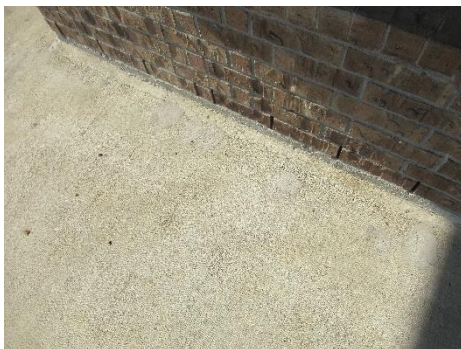
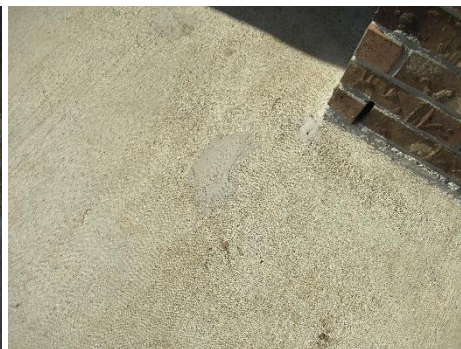
- Repairs have been made to the front patio.

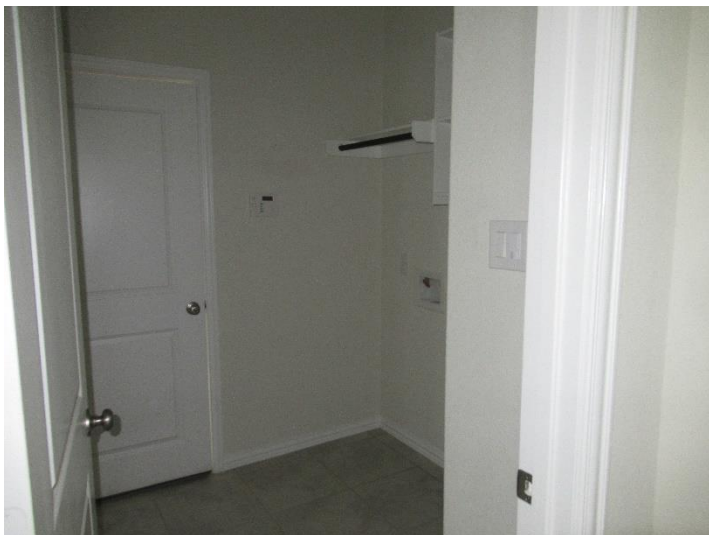
- The laundry room smells like garbage.

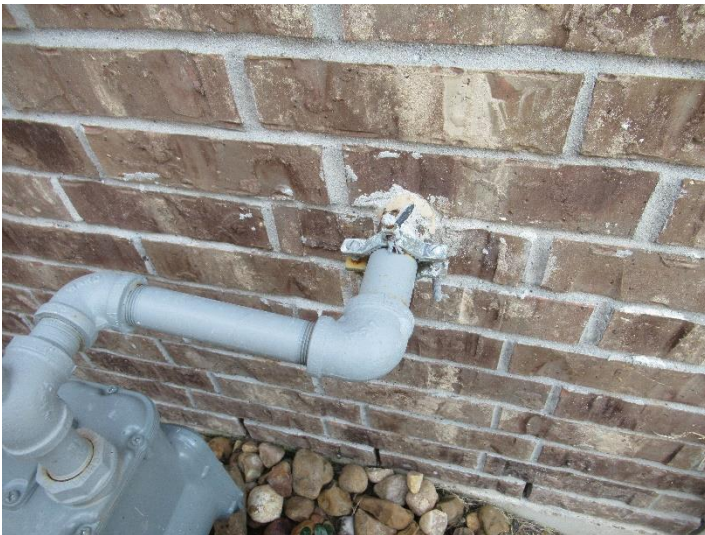
- ✚ All electrical systems are required to be grounded and bonded back to the electrical panel. There is a bonding cable and clamp located at the main gas meter/valve but it was unable to be verified for complete/correct installation and full electrical safety coverage. Consult a licensed electrician for additional information.

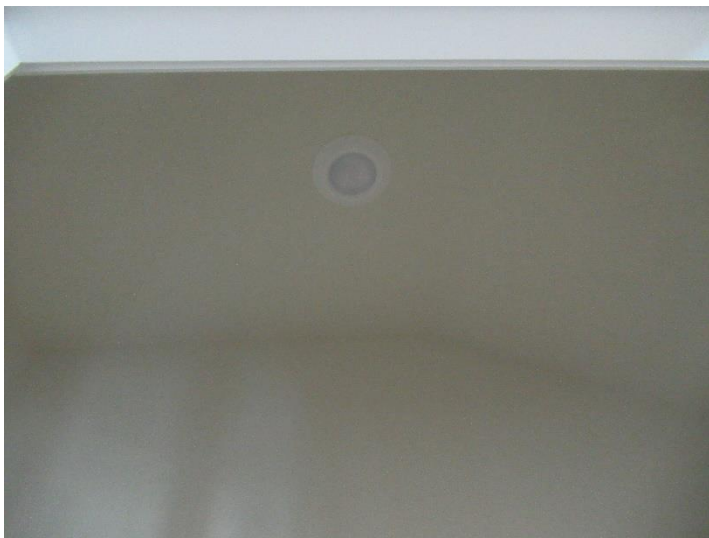
- The upstairs front-left bedroom closet light did not operate when tested.

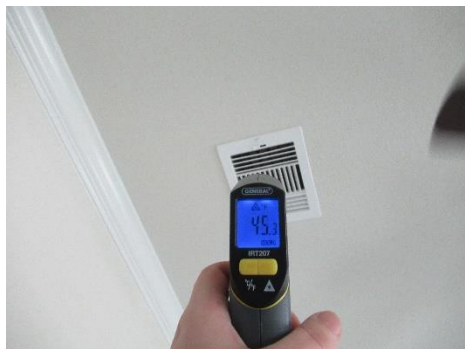
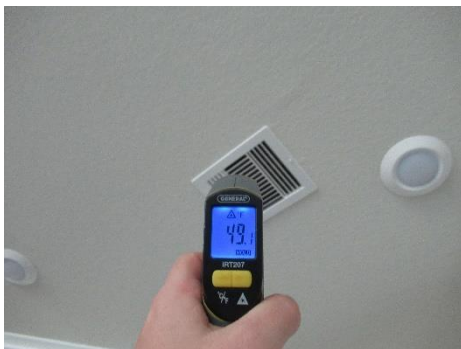
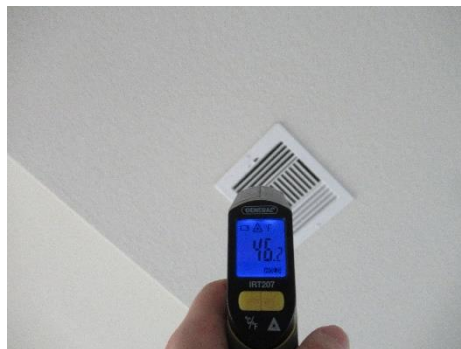
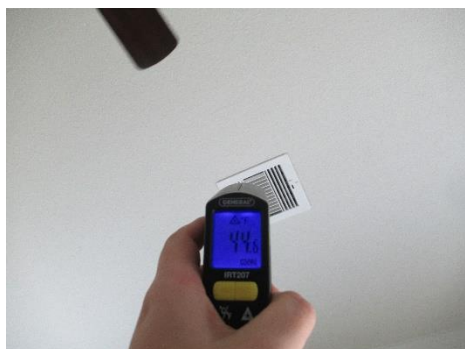
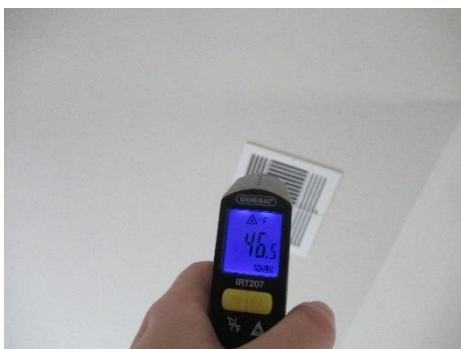
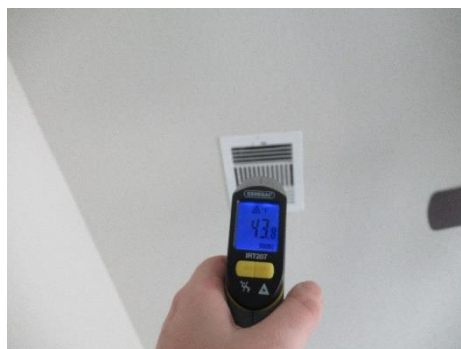
When operationally tested, the temperature differential between supply (conditioned air) and return air measured within the acceptable range of temperature differential and the unit appeared to be functioning as intended at the time of the inspection.

Supply (6) temperatures throughout the home.

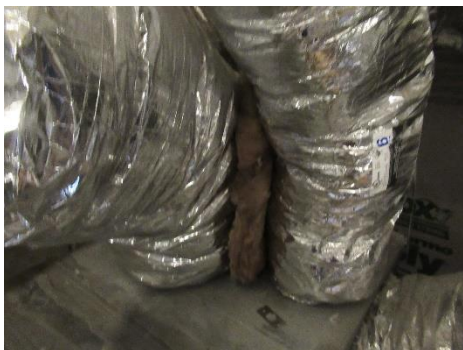
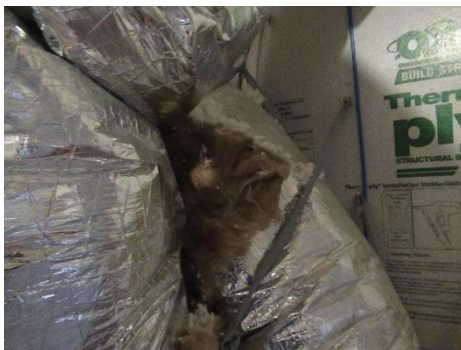
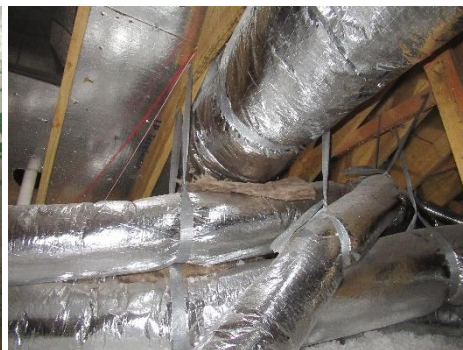
- Ductwork in the attic will develop damaging condensation when it is in contact with attic insulation and/or other ductwork.

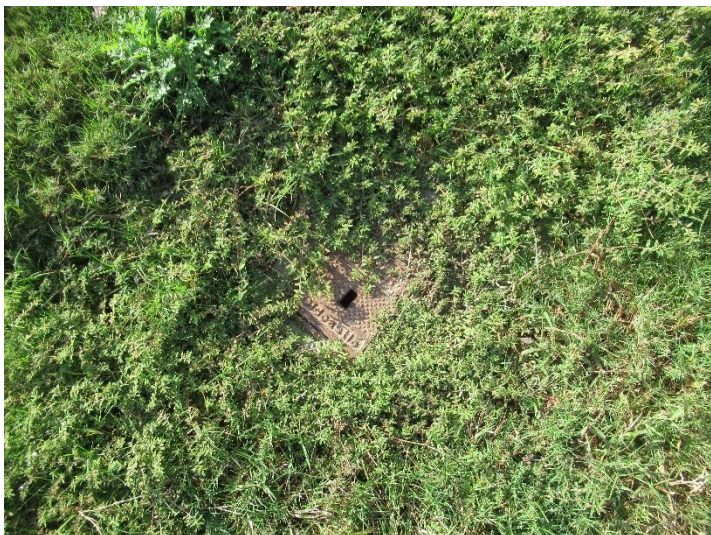
- ✚ *Location of water meter:* Front left curb

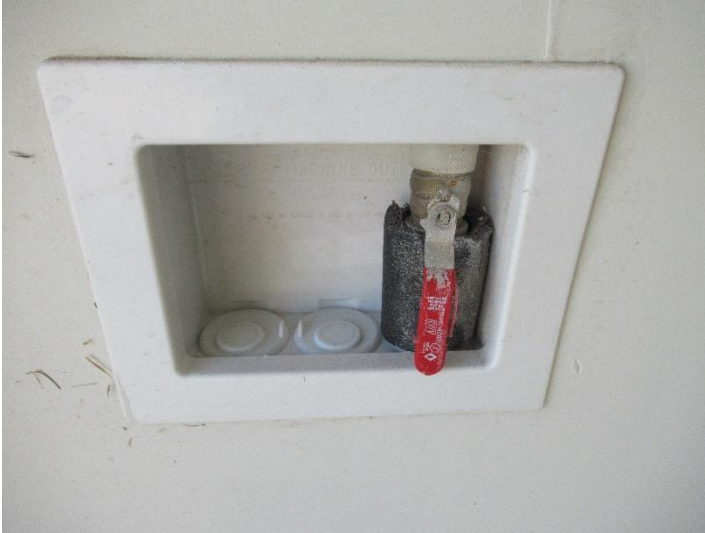
✚ *Location of main water supply valve:* Left interior garage wall

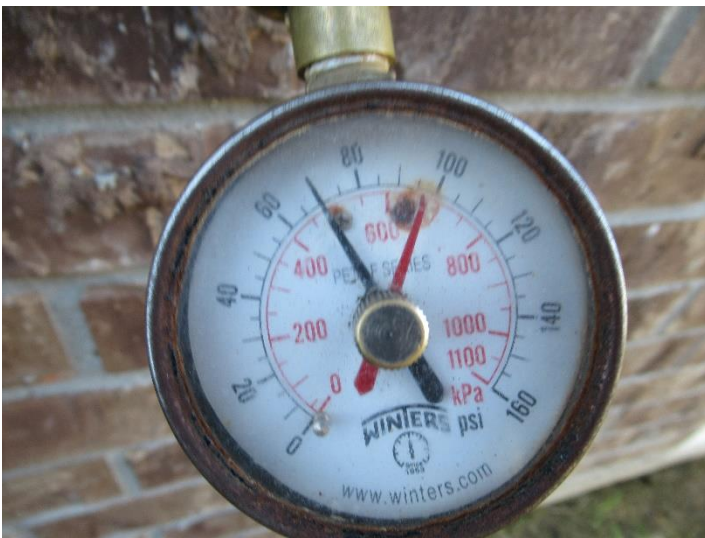
✚ *Static water pressure reading:* Approximately 70 PSI (40 PSI to 80 PSI required)

*Comments:* PEX water piping. Water piping beneath the ground and in the concrete slab are not able to be inspected due to the lack of visibility. It may be prudent to engage a plumber to conduct hydrostatic testing of the piping to determine if a deficiency exists beyond the scope of this inspection.

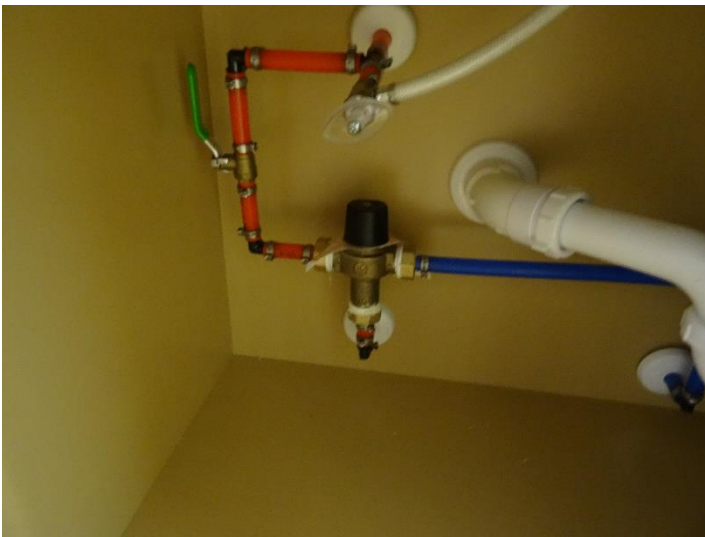
Hot water supplied to bathtubs and whirlpool bathtubs shall be limited to a temperature of not greater than 120°F (49°C) by a water-temperature limiting device that conforms to ASSE 1070 or CSA B125.3, except where such protection is otherwise provided by a combination tub/shower valve in accordance with [Section P2708.3](#).

- The bathroom tubs and shower water supplies lack a required temperature control valve.

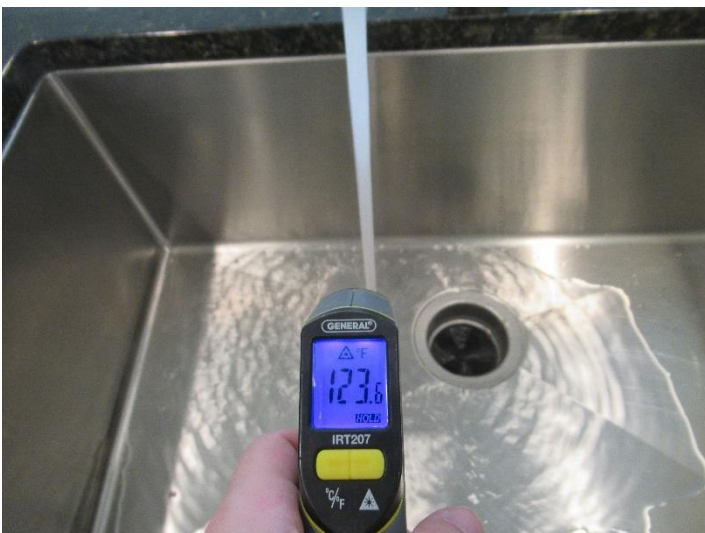
- The water temperature as recorded at the kitchen sink is too hot. Temperatures in excess of 120°F can cause severe burns and scalding.

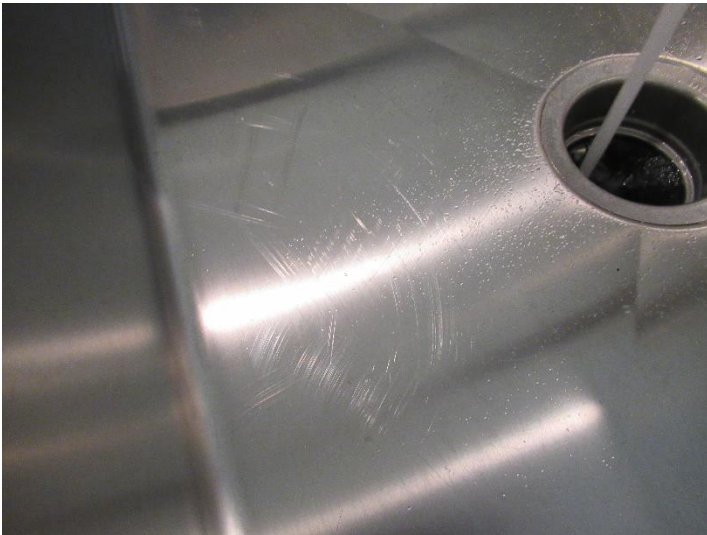
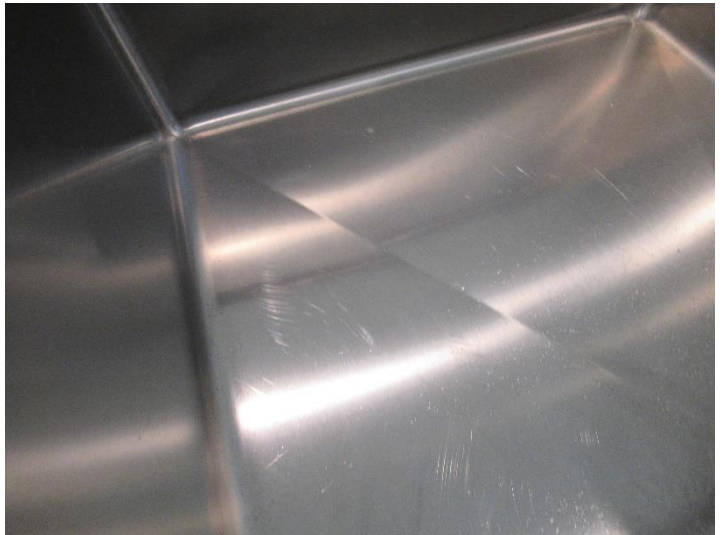
- The kitchen sink displays damage (scratches).

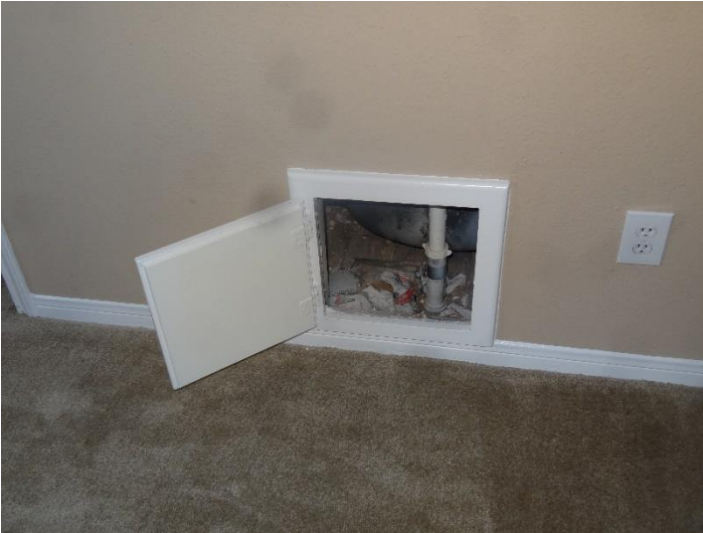
- To readily access plumbing connections in bathrooms for showers and bathtubs it is a recommended procedure to have access openings installed in walls adjacent to/behind in-wall plumbing fixtures. Currently, there are no plumbing access openings for the bathrooms of the home.

Example of opening for drain and plumbing inspection

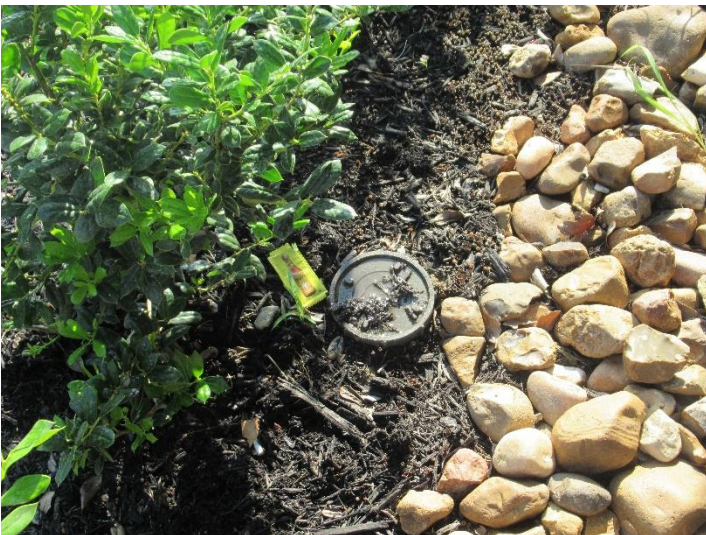
- ✚ The main drain clean-out for the home appears to be located in the front left flower beds.

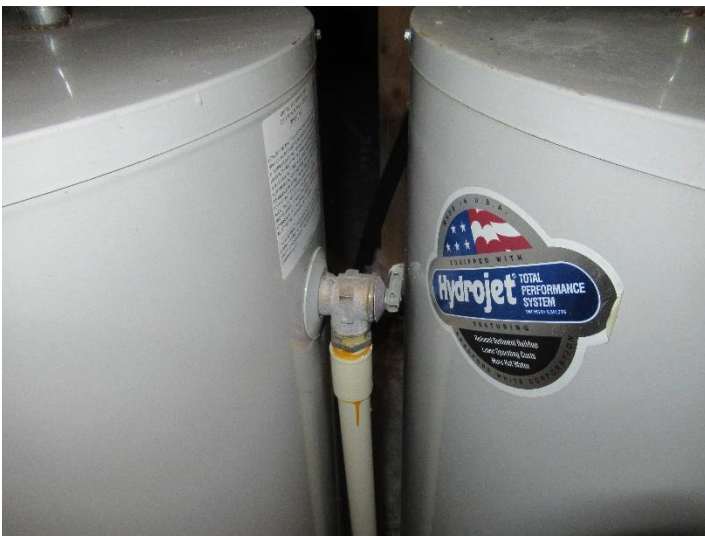
- The water heaters are too close together. The T&P valve for the left water heater is unable to be opened. The water heaters should be moved further apart.

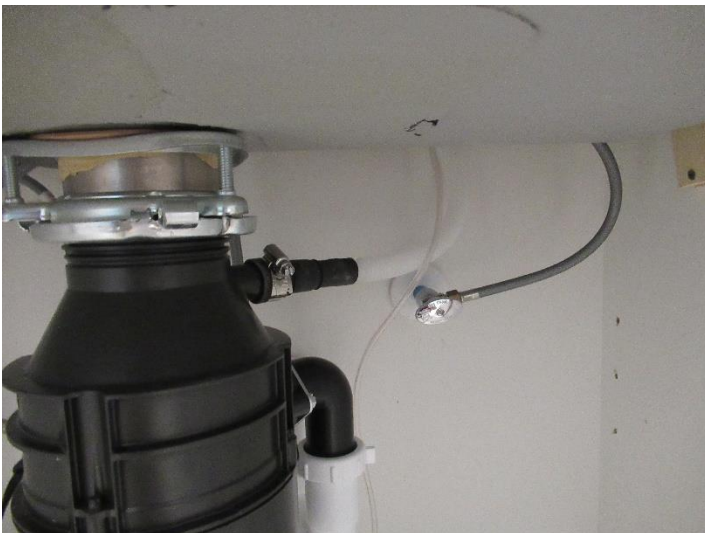
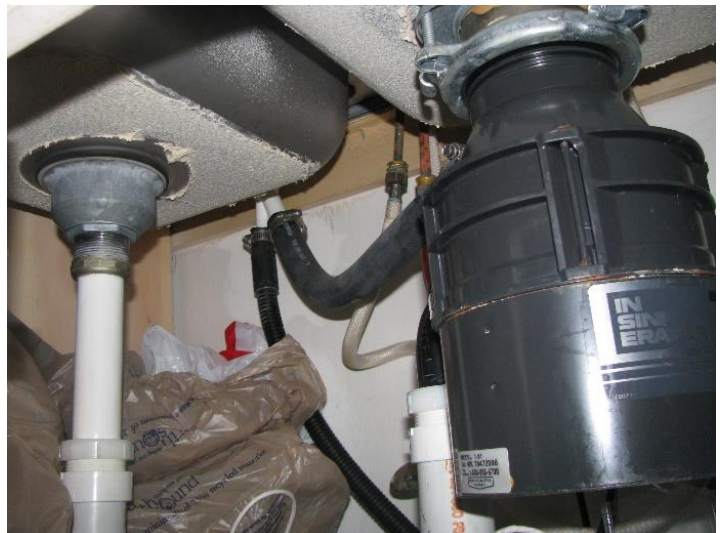
- Drainage from the dishwasher requires the drain line to be elevated above the top of the disposal with a loop at least 2” above the entry point to the disposal serving as an air gap to prevent gray water from backflow into the dishwasher. As an alternative to this method, an aerator can be installed at sink top with the dishwasher drain line going directly to the aerator. It is preferred that a second drain line from the aerator be attached to the top of the disposal to enable further processing of waste water and food particles.

Current and example of required installation

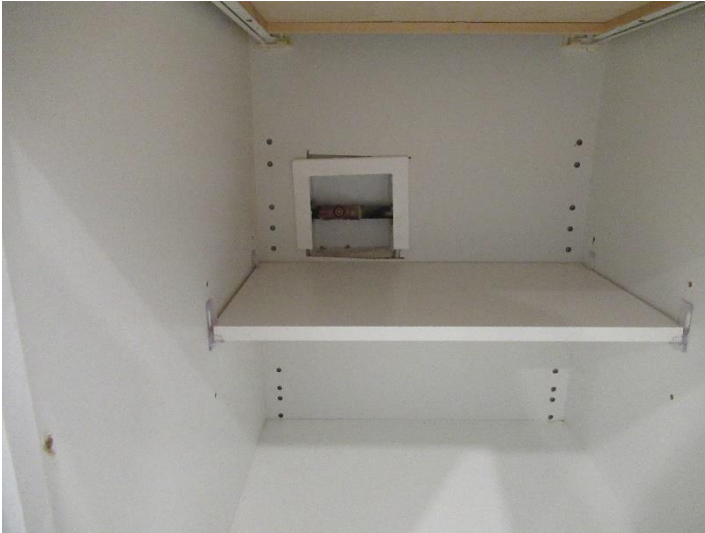
✚ The emergency gas shut-off valve for the appliance is located in the right lower cabinet.

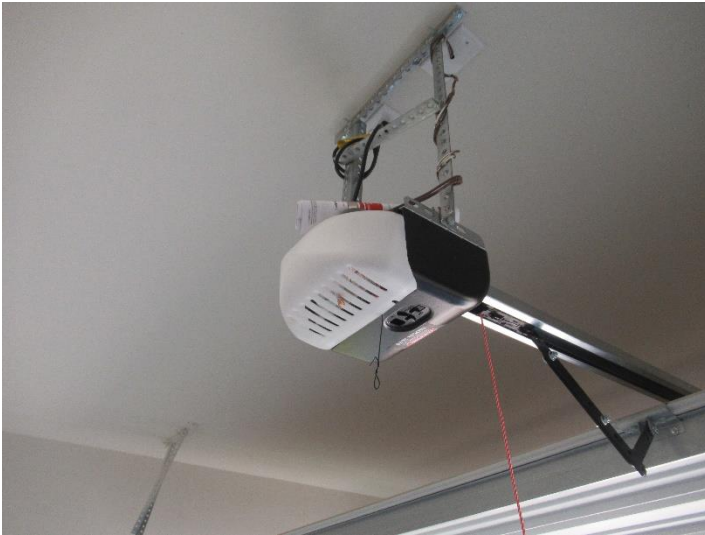
- The ground level safety beam/eyes should trigger the panel lighting when the beam is broken for safety at night or during dark periods.
