# PROPERTY INSPECTION REPORT

## “AROUND THE HOUSE” HOME INSPECTIONS

By: **David J. Stiles Inspector Lic. #7308** **3/19/2019**

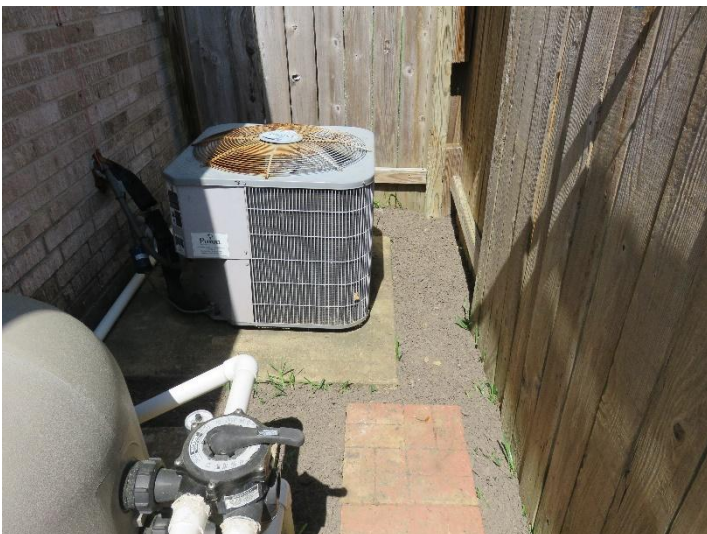
- Drainage at the left side of the home is not installed to allow for proper drainage. Improved drainage is needed.

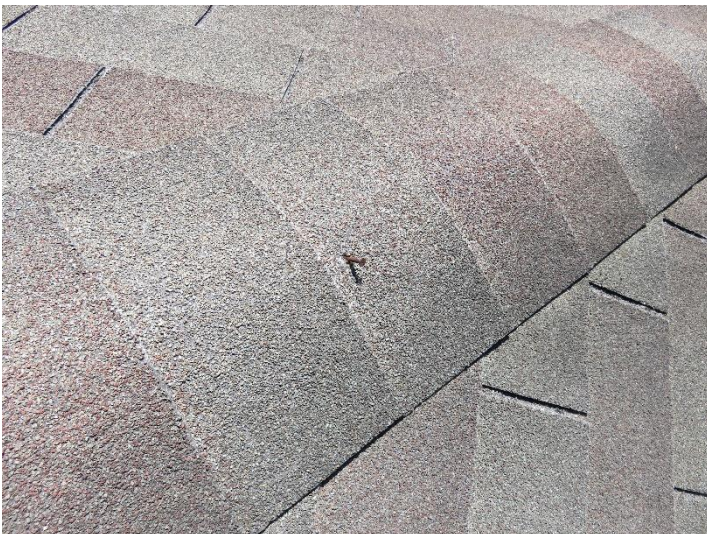
- At the right rear roof ridge, a rogue nail is exposed and protruding from the roof.

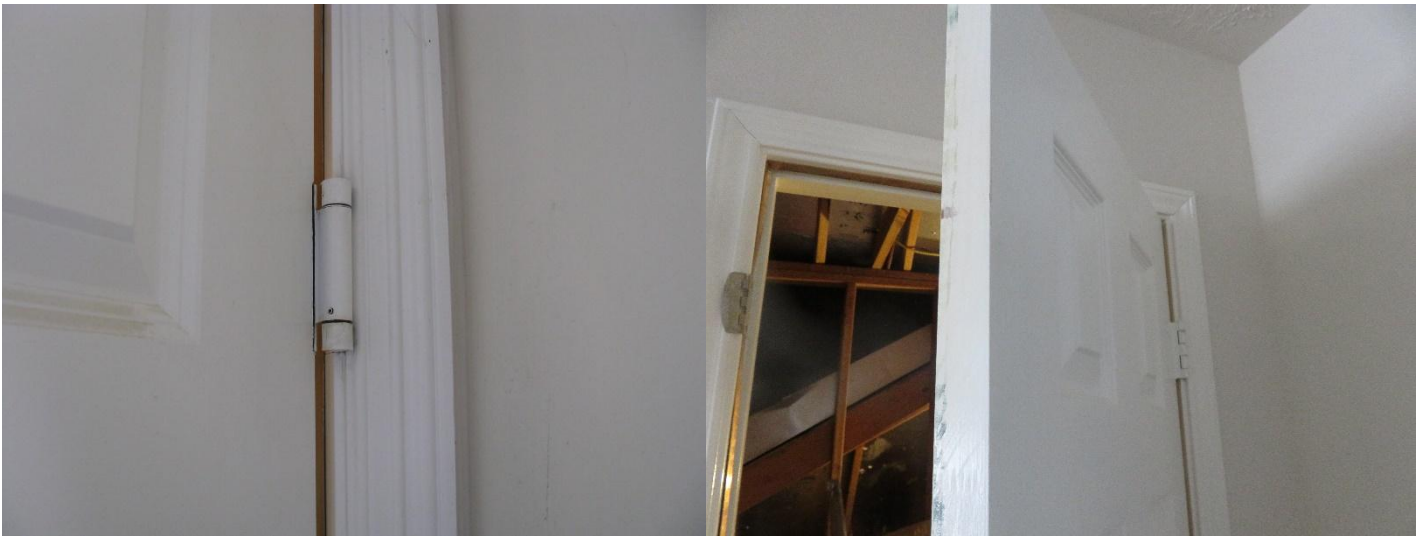
Example of a self-closing hinge and current installation

- The home-to-garage door, because the home is attached to the garage, is required to be 1 3/8" thick, fire rated and is required to be equipped with a self-closing hinge or other self-closing device (IRC – R302.5.1) to assist in preventing the spread of fire, smoke and combustion in the event of a fire. Verification that this door is fire-rated was not available and the door lacks a self-closing device..

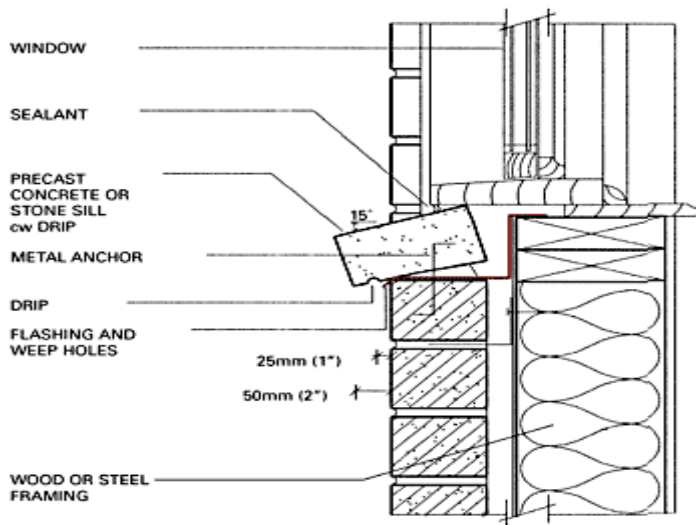
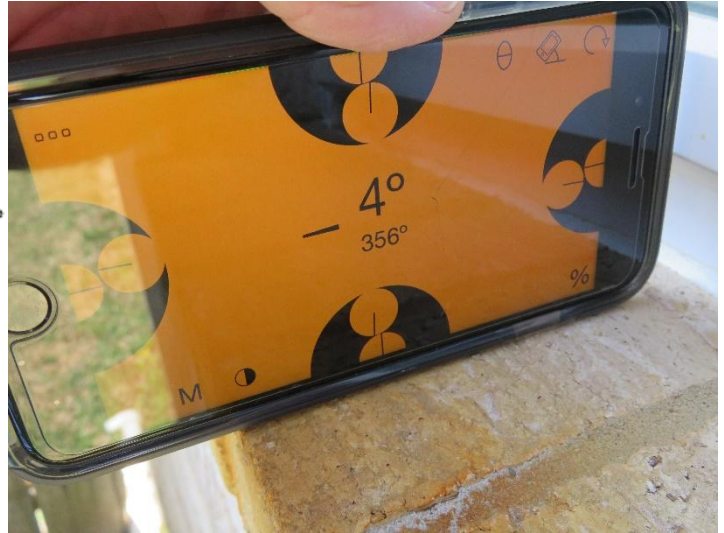
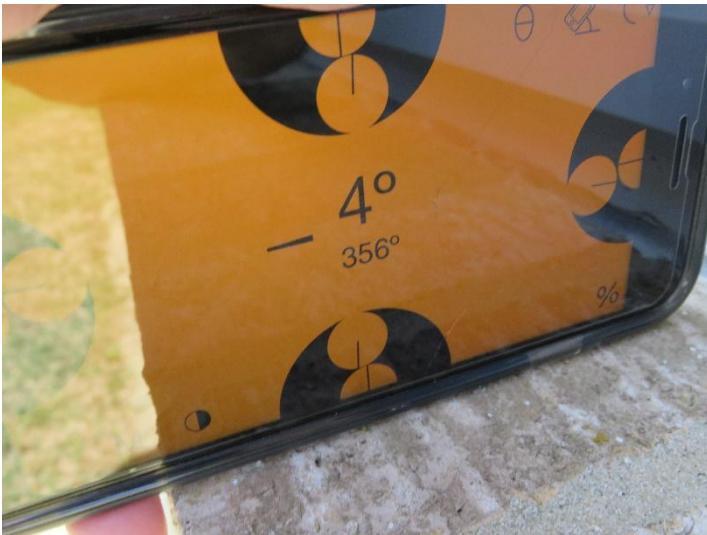
Illustration and current installation examples

- Exterior window sills are required to be installed to slope at least at a 15\* angle away from the home/window to properly drain/shed water away from the home.

- All exterior window sills should be filled/caulked to assist in preventing water leakage into the home.

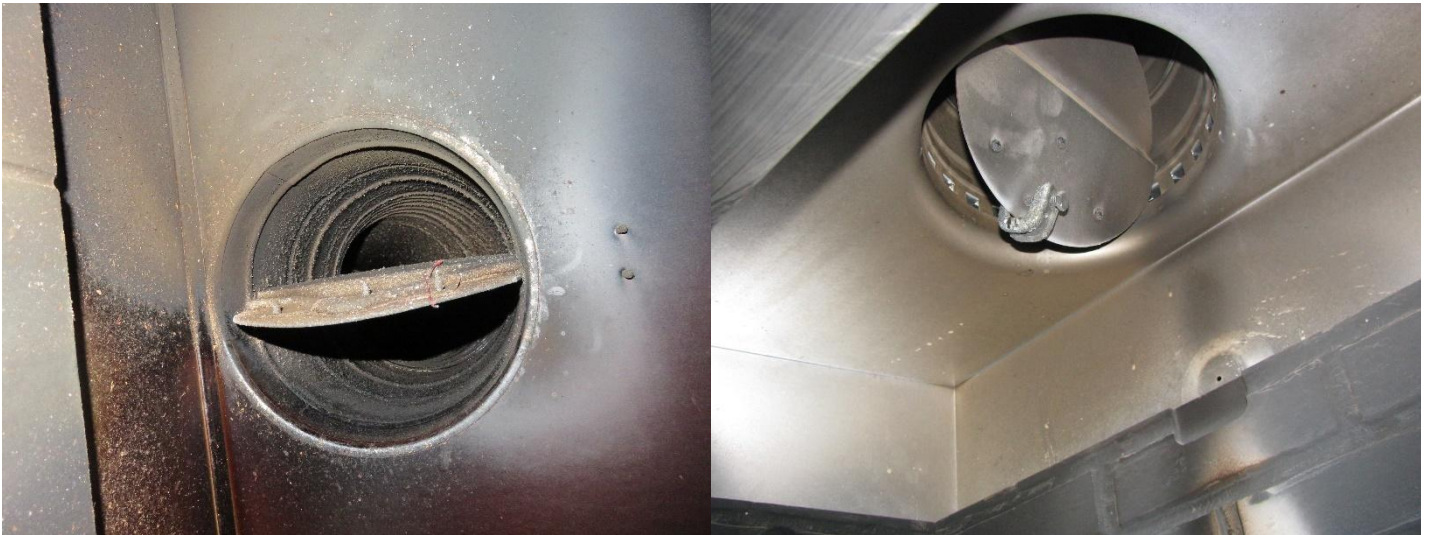
Current installation and example of a “C” clamp

- The damper inside the firebox is required to be equipped with a “C” clamp/damper block that provides an opening for constant fresh air flow.

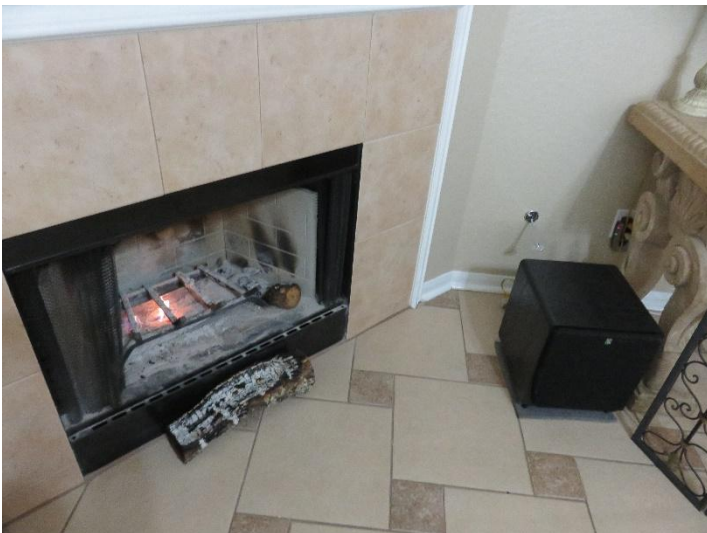
- The fireplace and chimney should be professionally cleaned prior to continued/next use.

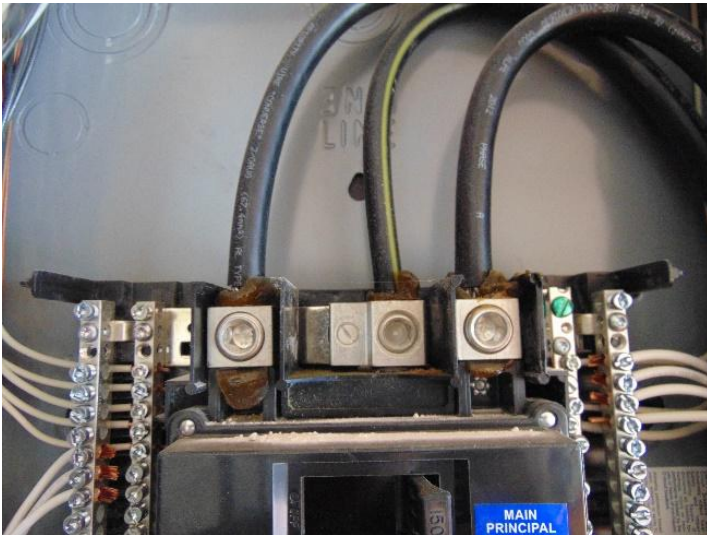
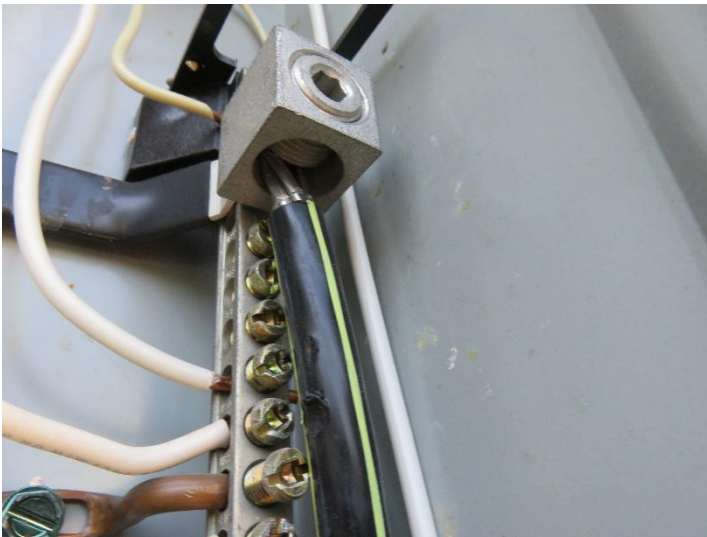
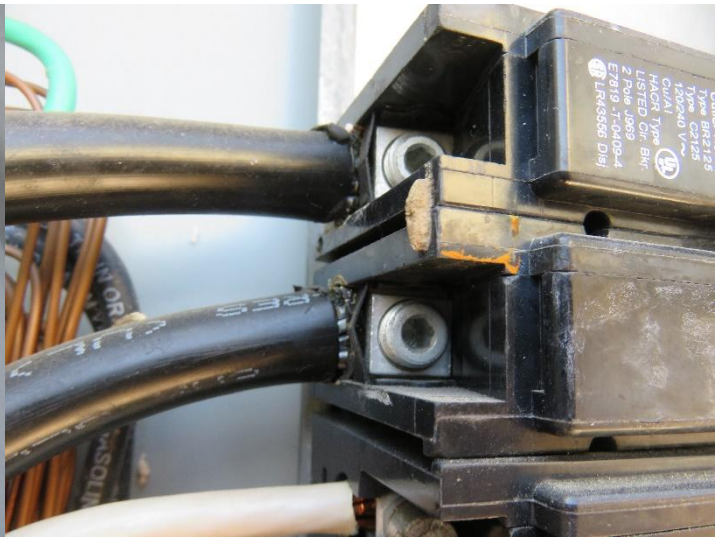
Current and required installations

- Aluminum service wiring requires anti-oxidizing agent at entry points to the main breaker and neutral bar.

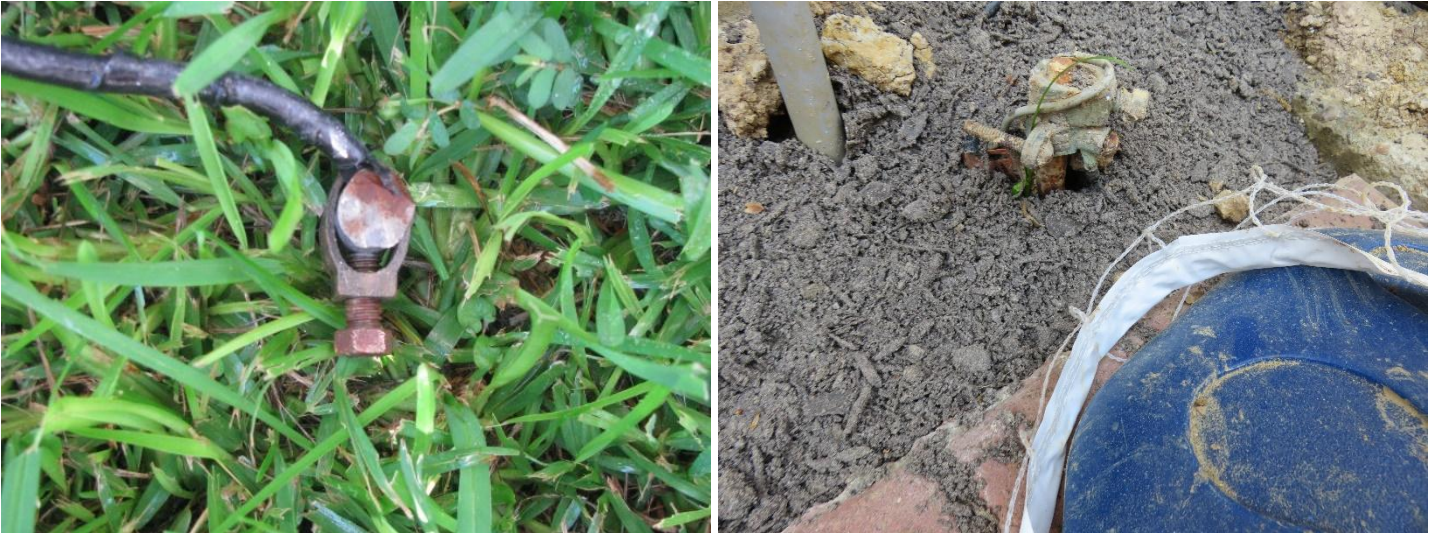
Example of an acorn clamp and current installation

- The installed grounding clamp at the ground rod is for use in a natural gas pipe application. Grounding rods are required to have an acorn grounding clamp.

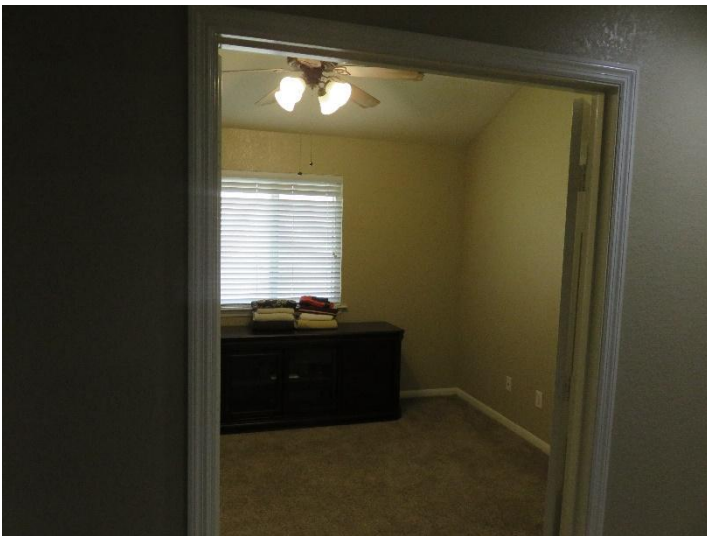
- The left side center bedroom electricals lack wiring to a fire safety AFCI safety breaker.

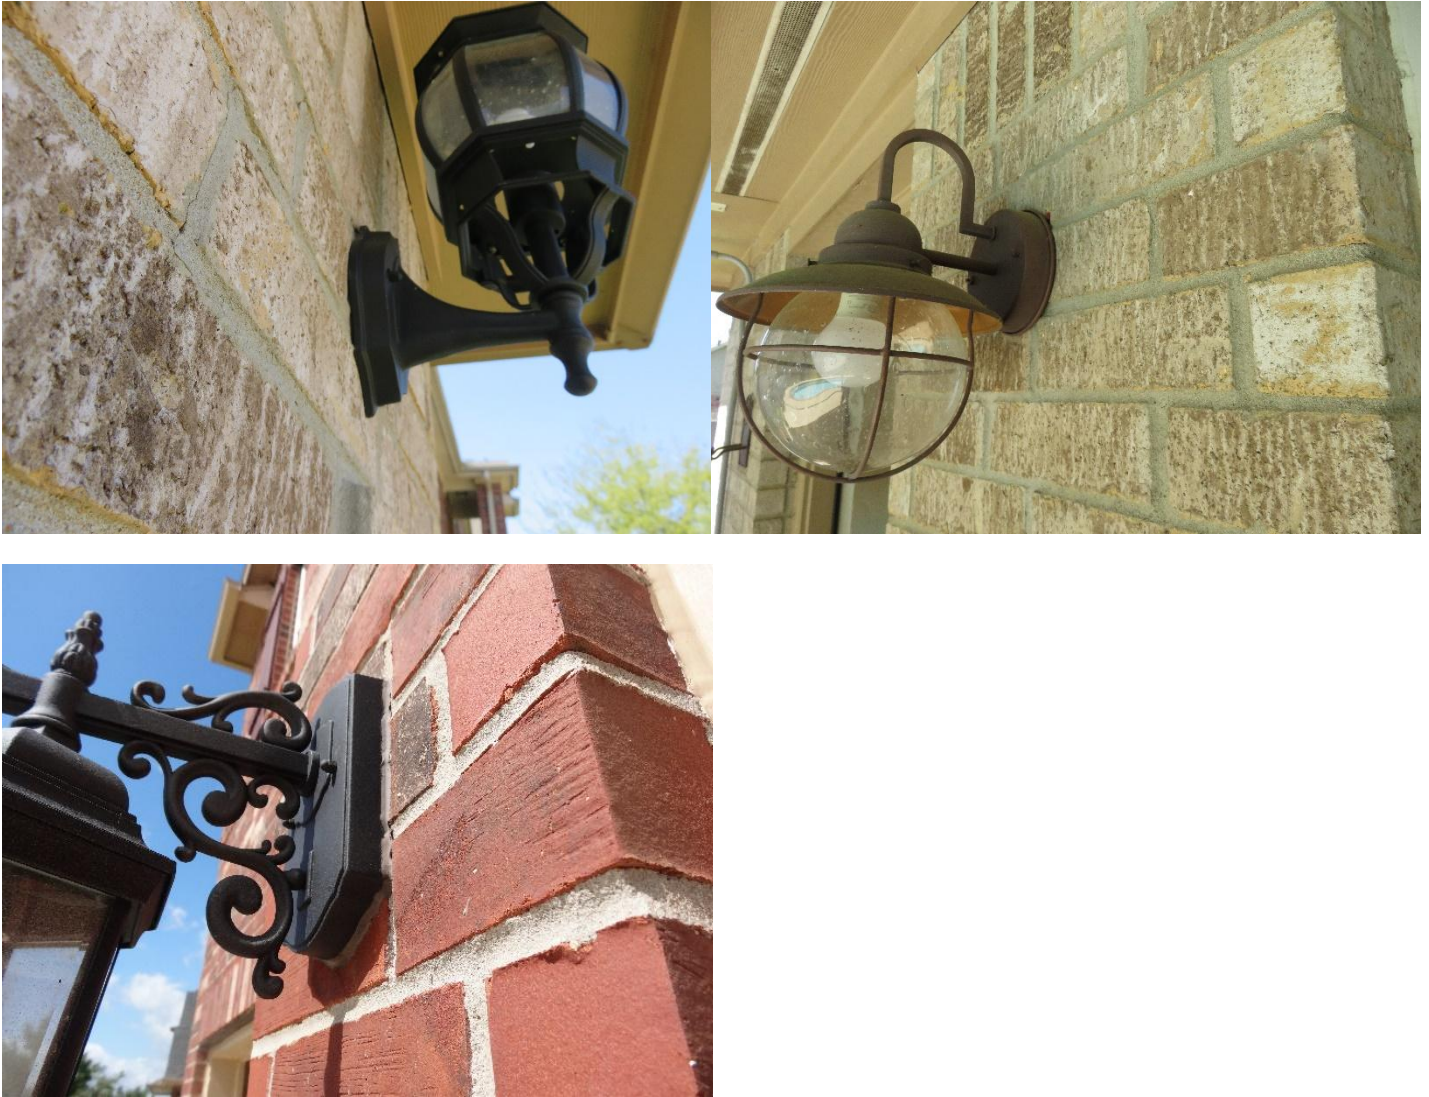
Current (2) and recommended installation

- Exterior light fixtures should be caulked around its/their perimeter.

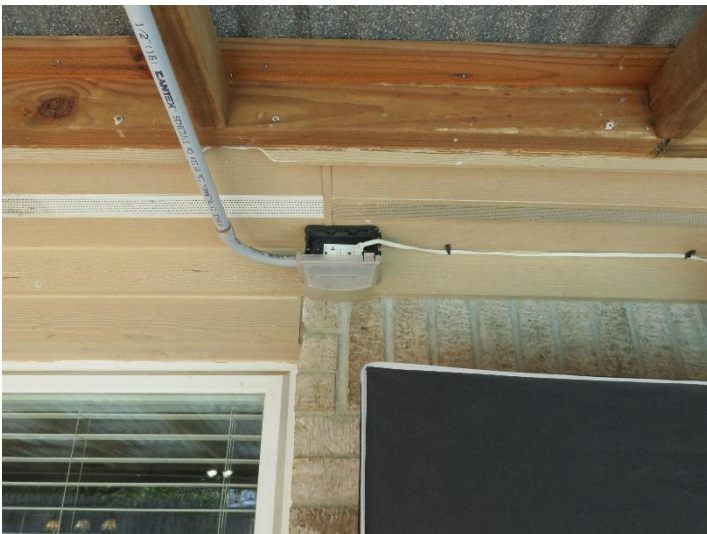
- The outlet at the rear upper patio wall is a GFCI apparatus but the weather cover is installed upside down.

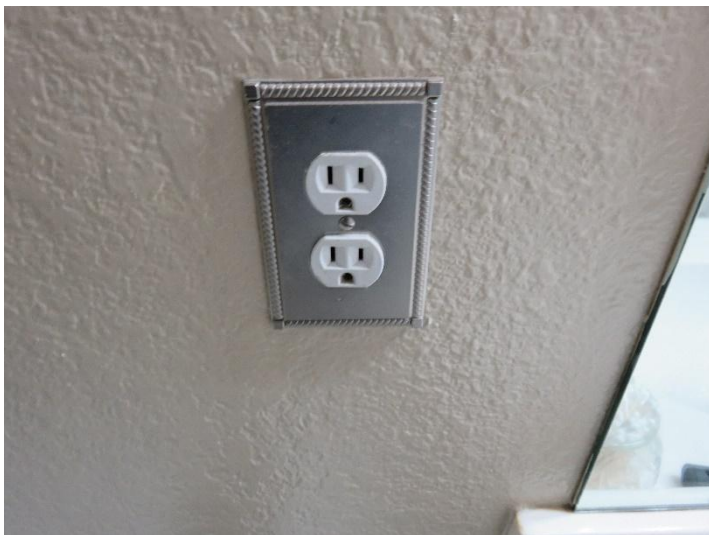
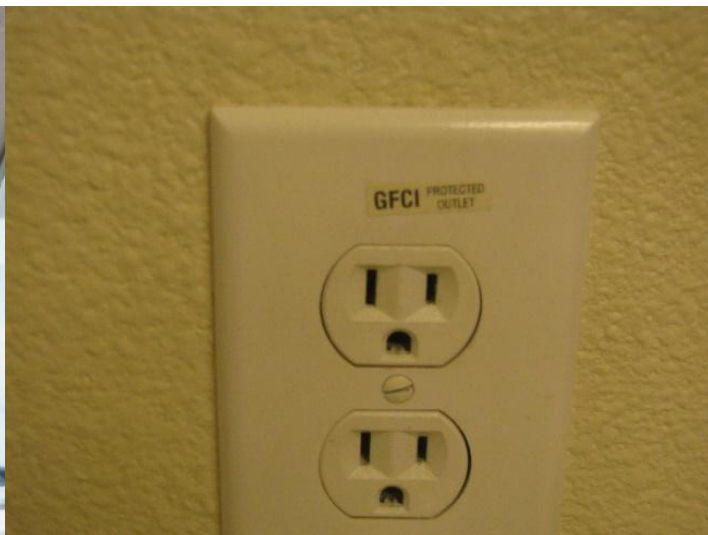
Current example in a bathroom and required labeling

- All 15 – 20 AMP laundry room outlets are required to be GFCI safety rated/protected - IRC{210.8(A)(9)} 9/2014
- All GFCI safety outlets should be labeled/marked with the familiar GFCI safety documentation. All garage, kitchen countertop, laundry room, bathroom and exterior outlets are required to be GFCI safety rated and labeled for identification.

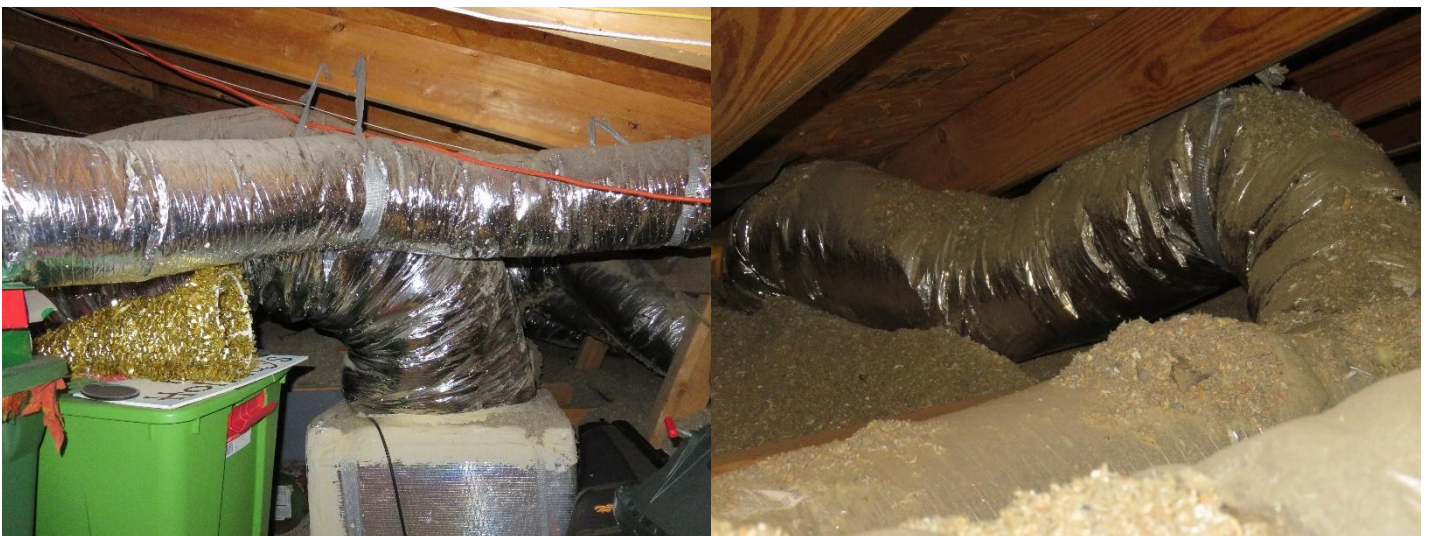
Examples

- Attic ductwork in general is prohibited from touching/coming into contact with other ductwork or installed lying on the attic floor. Insulation placed between sections is not a remedy. Damaging condensation can result.

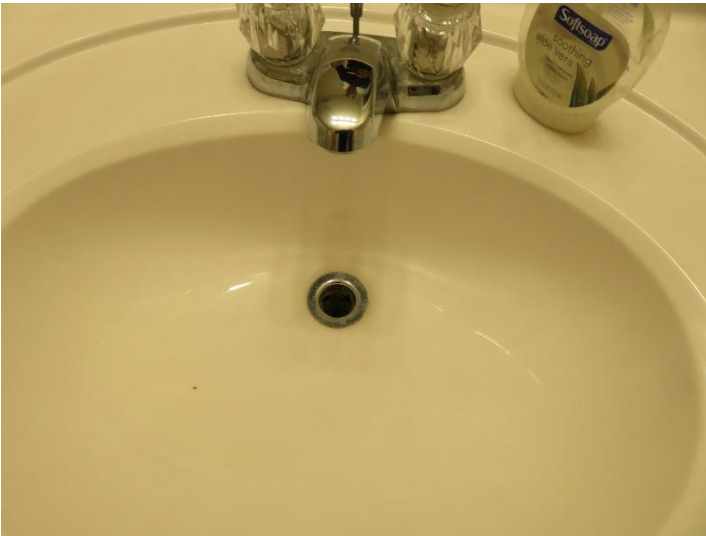
- The guest bathroom sink lacked a stopper.

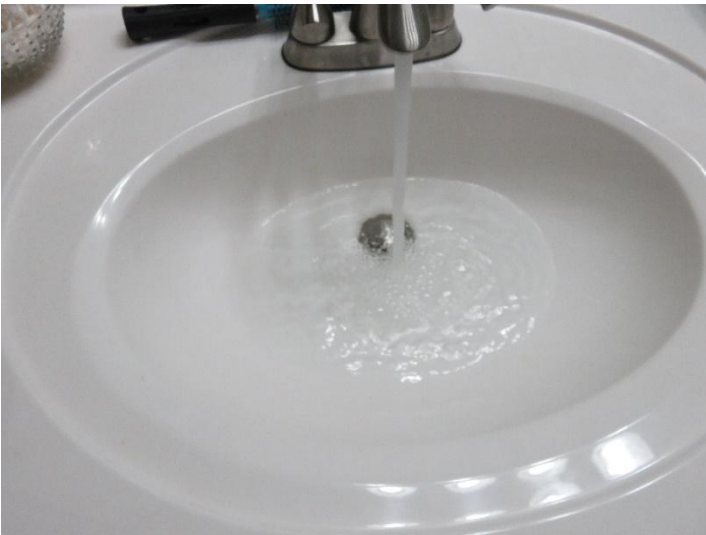
- The left sink in the Master bathroom lacks a functioning stopper.

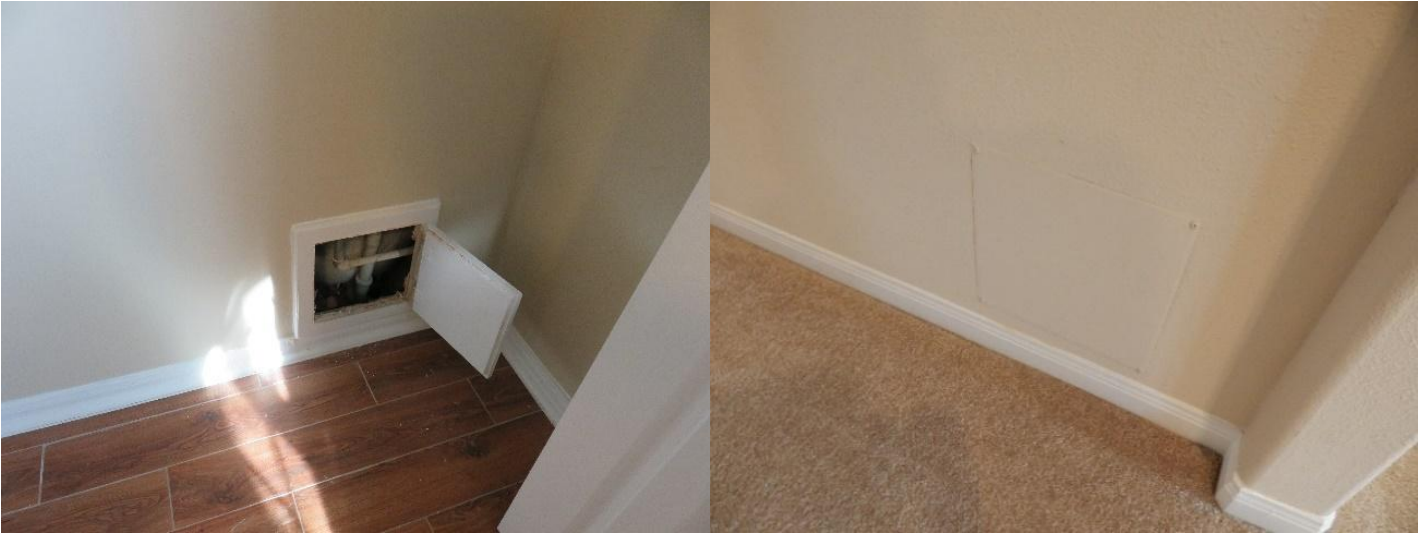
Examples of opening for drain and plumbing inspection

- To readily access plumbing connections in bathrooms for showers and bathtubs it is a required procedure to have access openings installed in walls adjacent to/behind in-wall plumbing fixtures. An access opening at least 12" X 12" is required for repair or replacement of concealed slip joints. The opening can be a ceiling or a wall. {IRC 33201.1} (UPC 404.2)

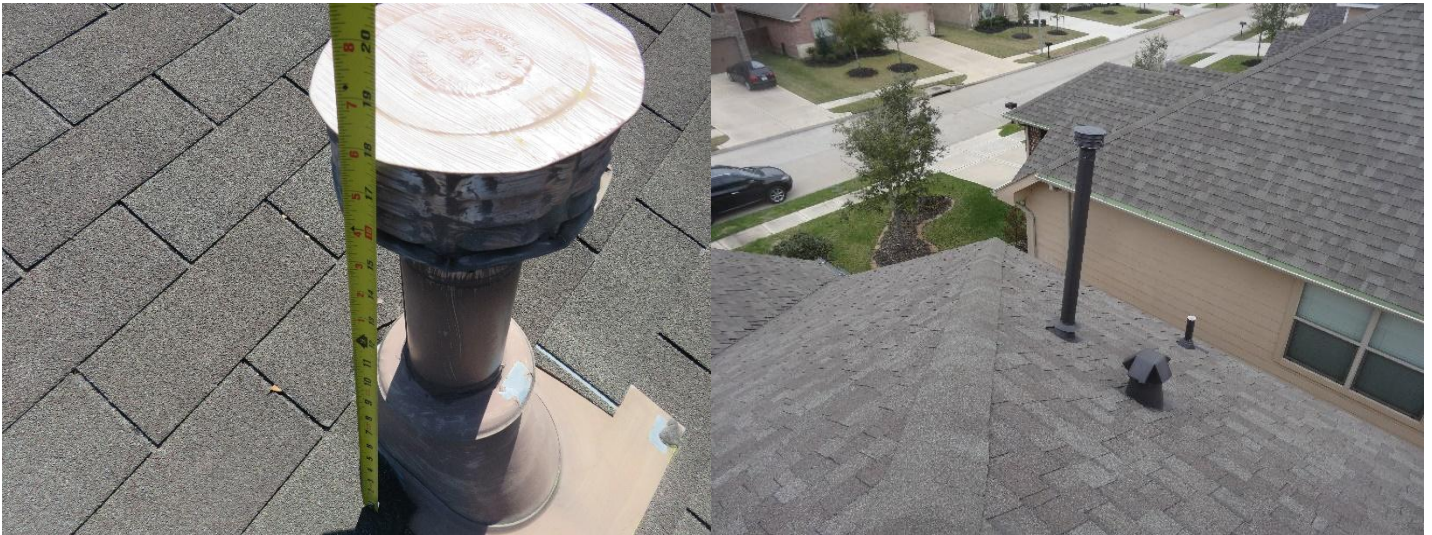
Current installation and required example

- The bottom of the “B” vent exhaust hood for the appliance(s) is required to be at least 24” above the roof deck anywhere within 10’ of any combustible materials and the roof deck. This installation also provides a preventative measure for backflow of gases back to the attic.

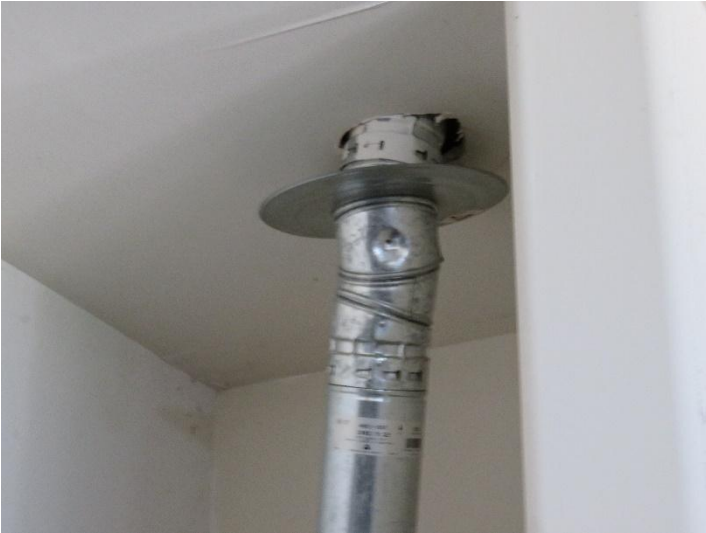
- The ceiling at the water heater lacks properly installed fire/combustion flange.

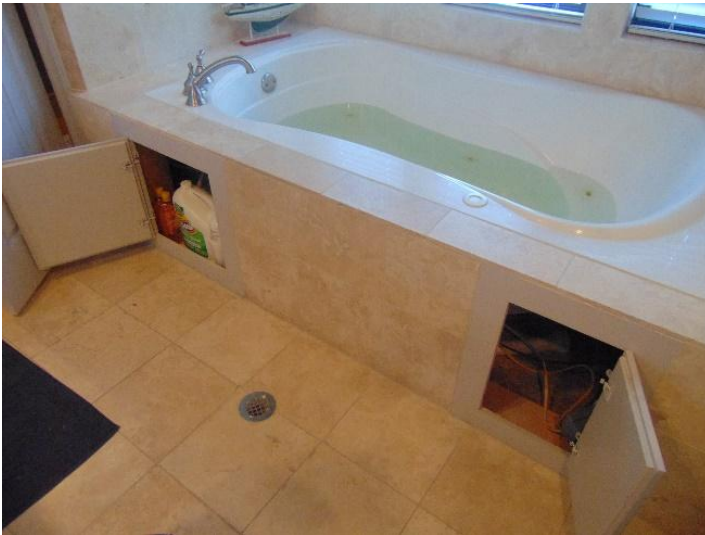
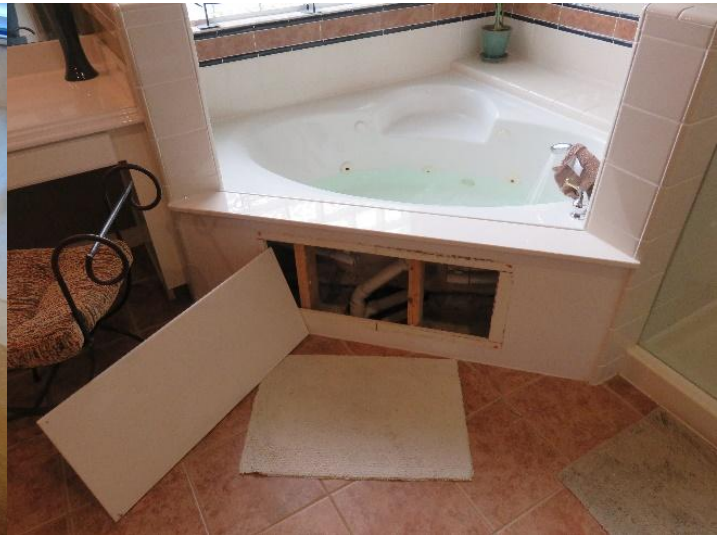
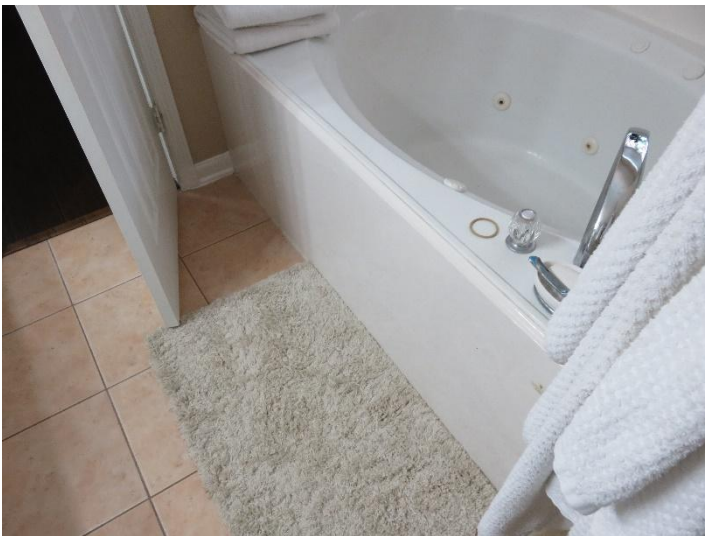
Required installation examples (2) and current installation

- The area (pump and drains) beneath the Jacuzzi should be readily accessible for inspection and repairs. {IRC P2720.1}

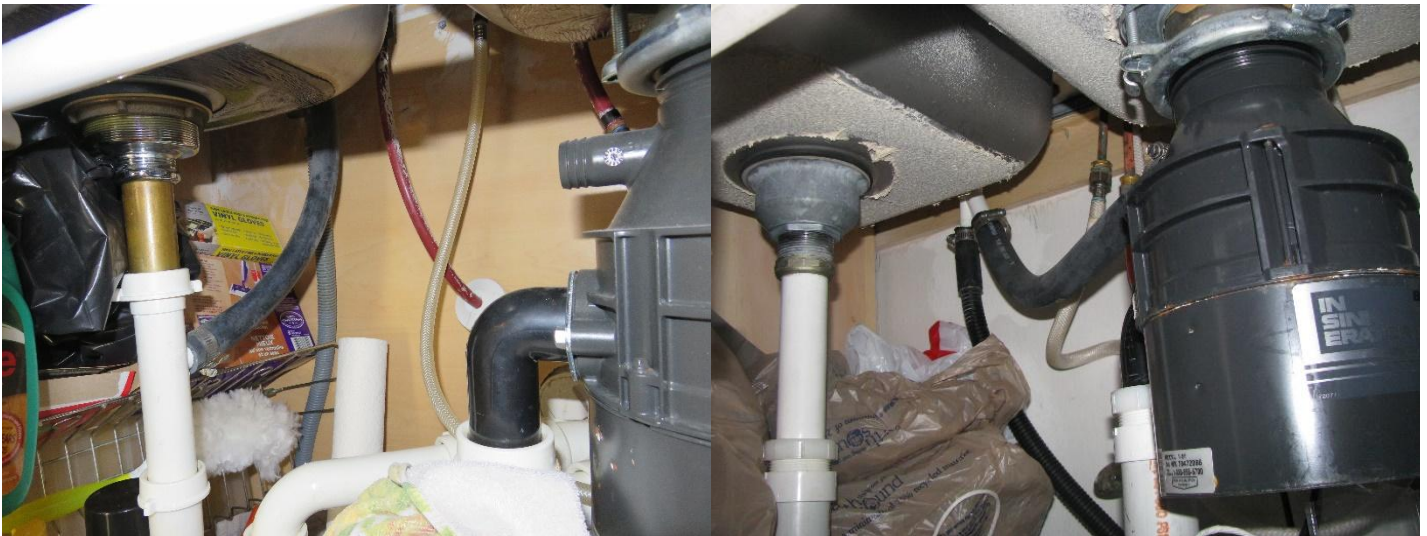
Current and example of required installation

- Drainage from the dishwasher requires the drain line to be elevated above the top of the disposal with a loop at least 2" above the entry point to the disposal serving as an air gap to prevent gray water from backflow into the dishwasher. As an alternative to this method, an aerator can be installed at sink top with the dishwasher drain line going directly to the aerator. It is preferred that a second drain line from the aerator be attached to the top of the disposal to enable further processing of waste water and food particles.

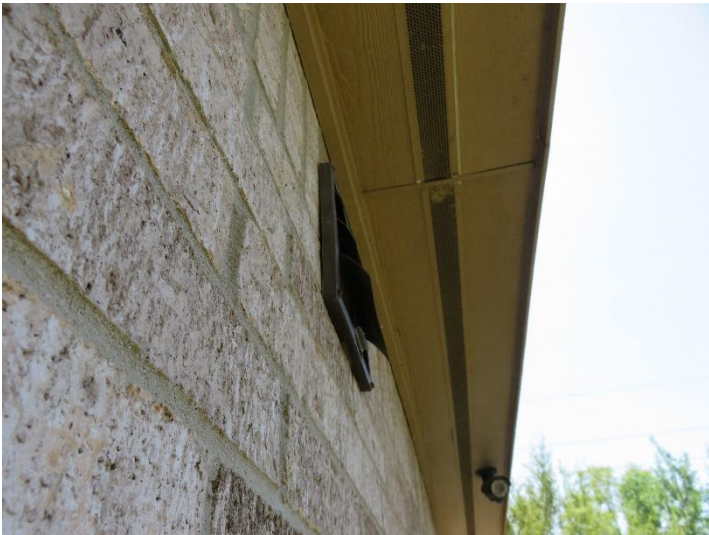
- The hood on the exterior wall should be caulked around it perimeter.

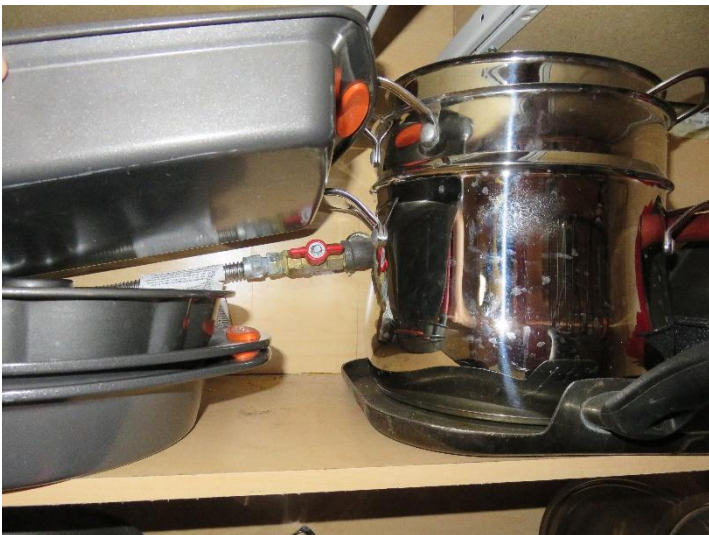
- ✚ The emergency gas shut-off valve for the cook top burners is located in the lower right cabinet.

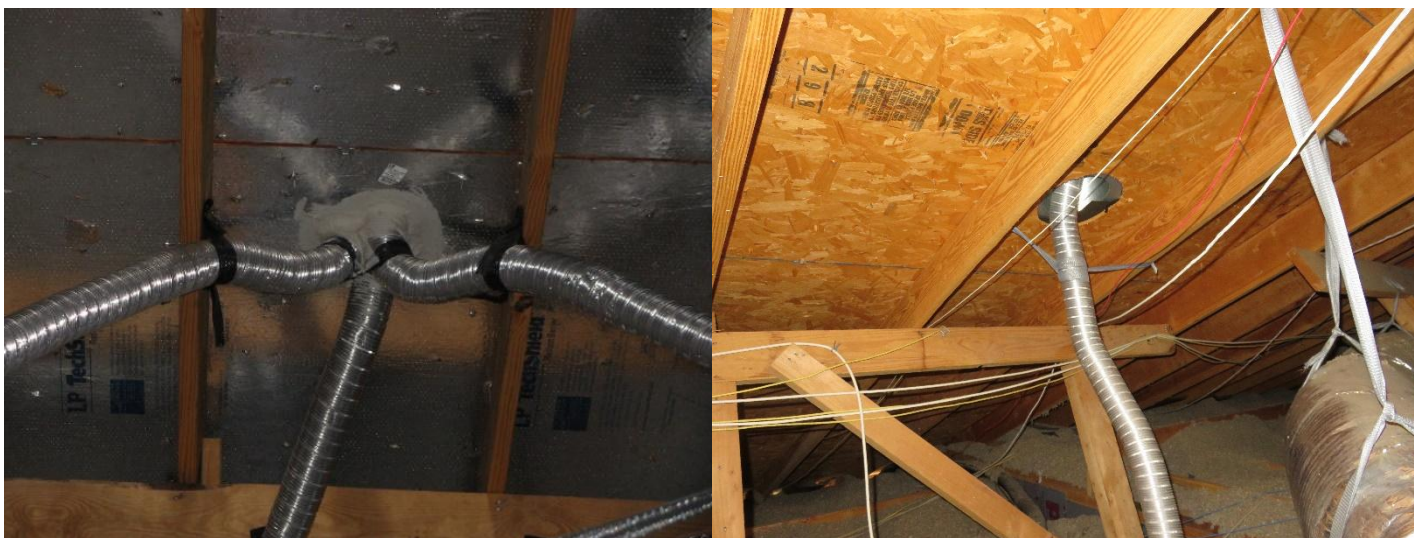
Example and current installation

- Exhaust fan ductwork in the attic rising through the roof deck should be sealed.

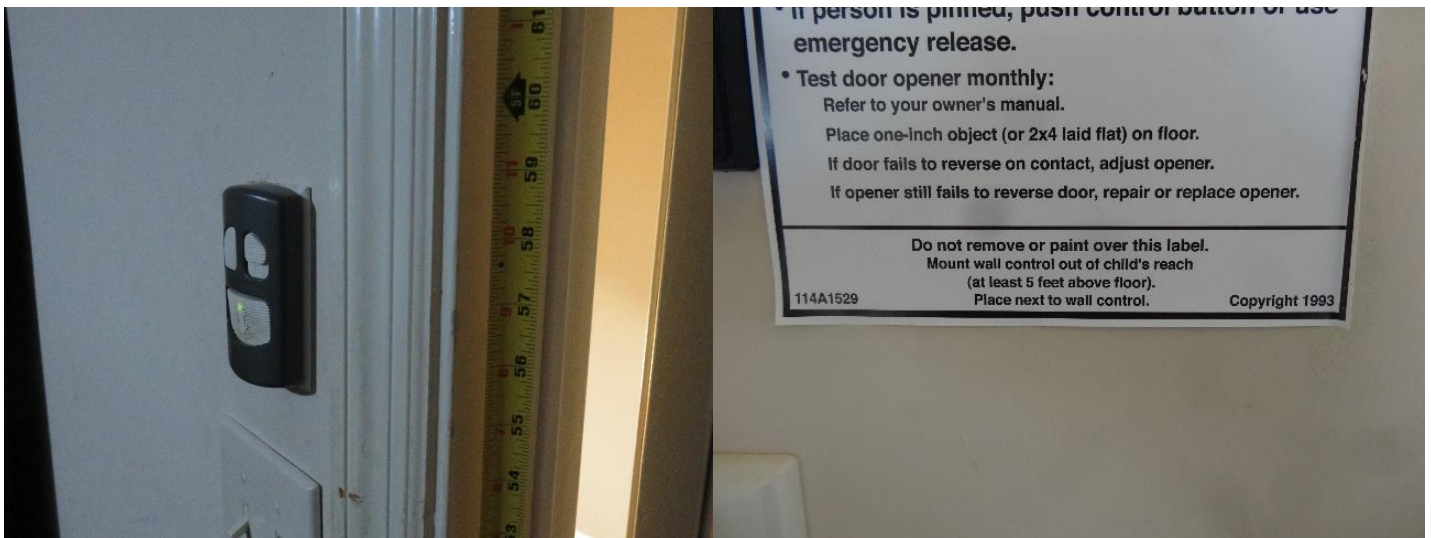
Current installation and required statement of installation

- The automatic garage door control button is too low compared to its recommended height of at least 5' above the floor or highest point of access. Preventing small children from being able to access and activate this button is a child safety feature of the door.

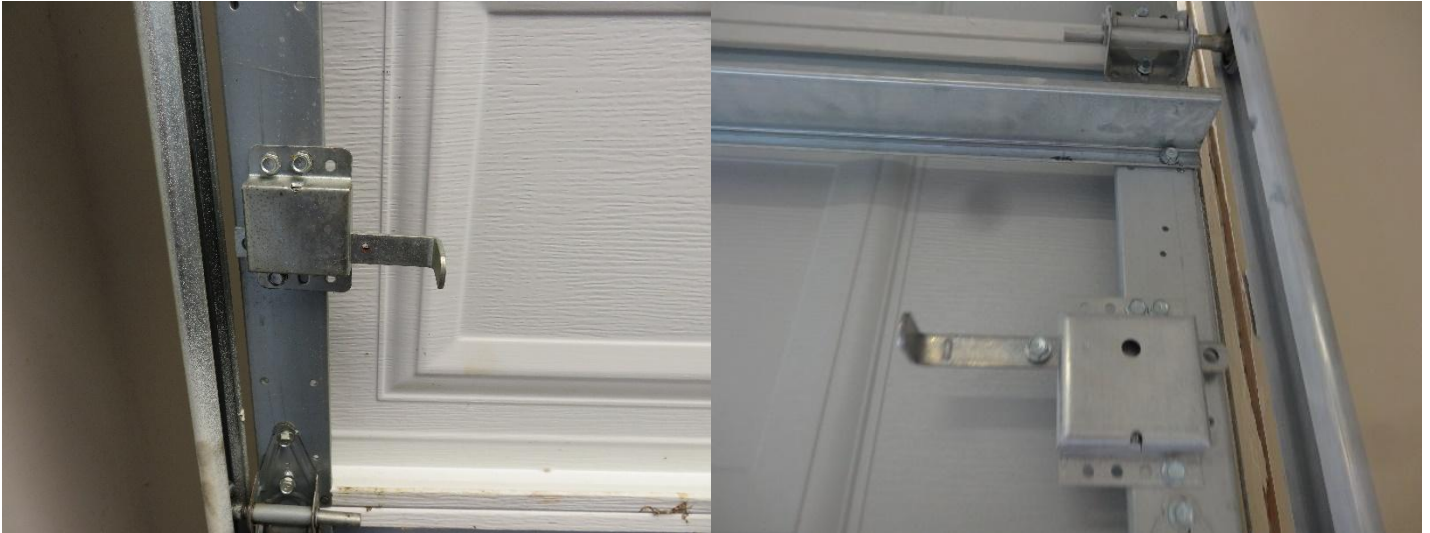
Current and example of a blocked manual lock

- Manual garage door locking devices should be removed or temporarily disabled while an automatic door opener is present and operational.

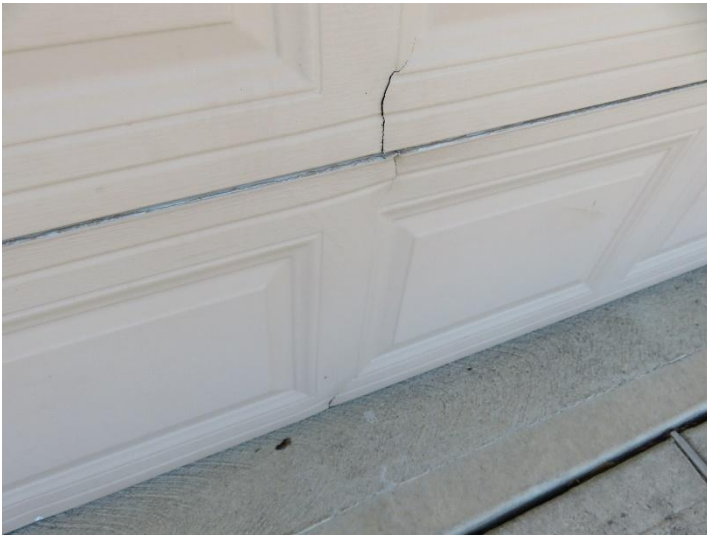
- The garage door displays split panels.

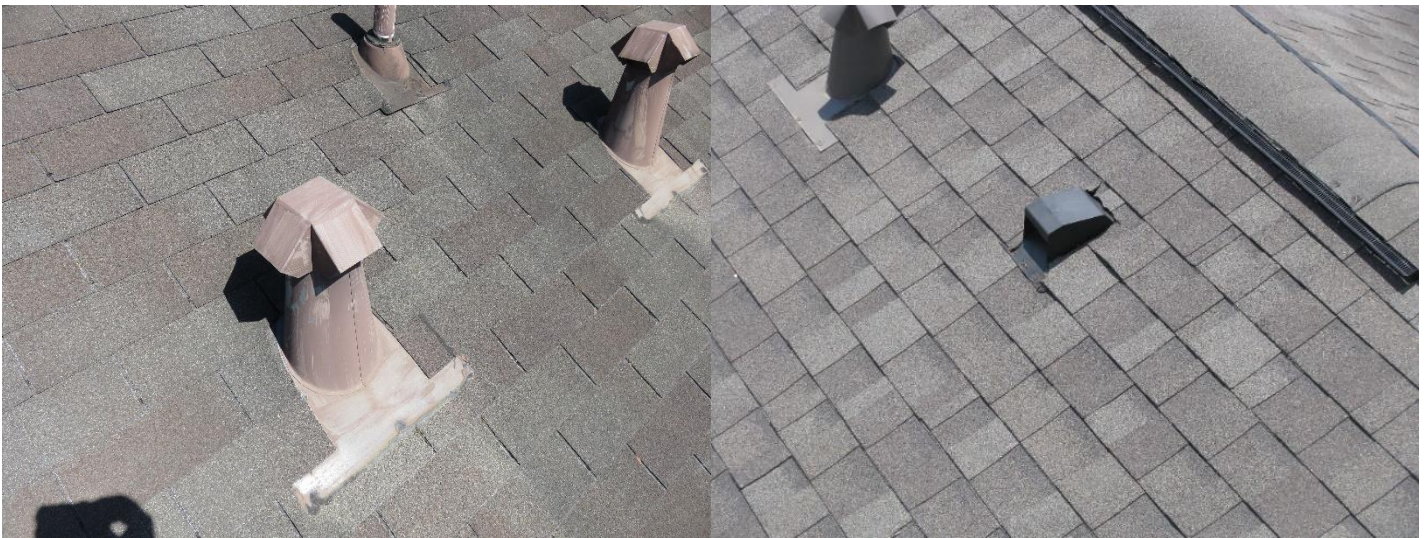
Current and required installation example

- The air handling hood installed for venting the dryer at the roof top is not the proscribed apparatus for this use. The correct hood is required to have a backflow preventer/damper to prevent air from pushing lint and moist air back into the ductwork. (IRC{2439.3}. *“End outside in backdraft damper and no screens”*)

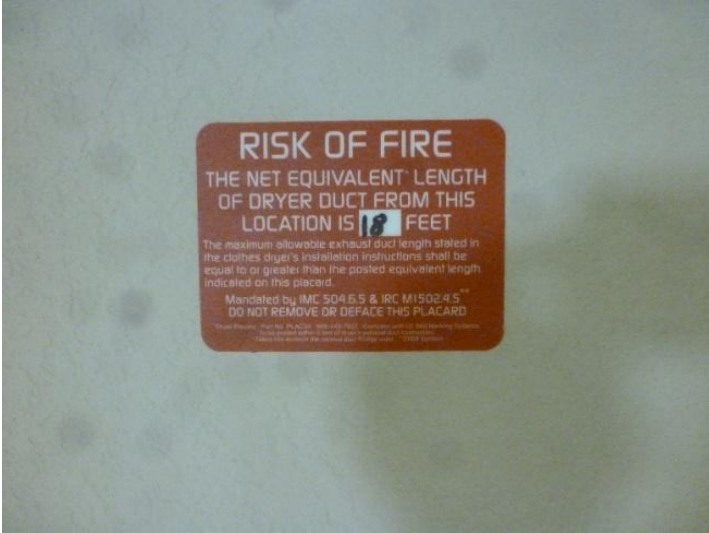
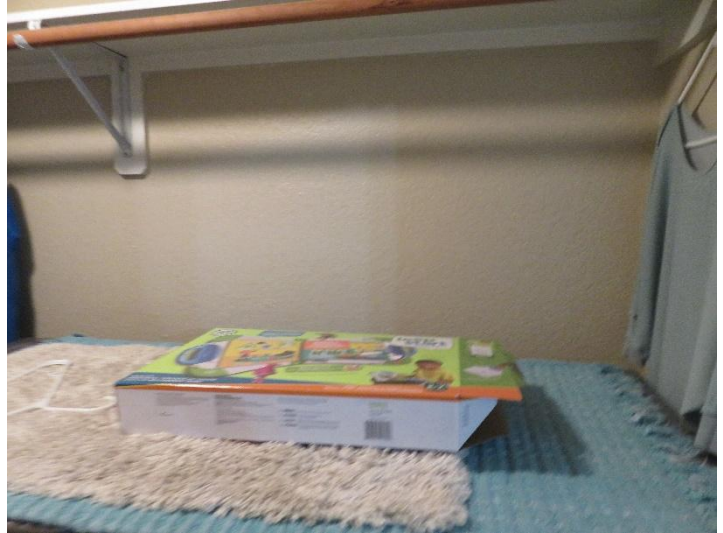
Example and laundry room wall

- Where the dryer exhaust duct is concealed within the building construction, the equivalent length of the exhaust duct shall be identified on a permanent label or tag. The label or tag shall be located within 6 feet (1829mm) of the exhaust duct connection. IRC 1502.4.5

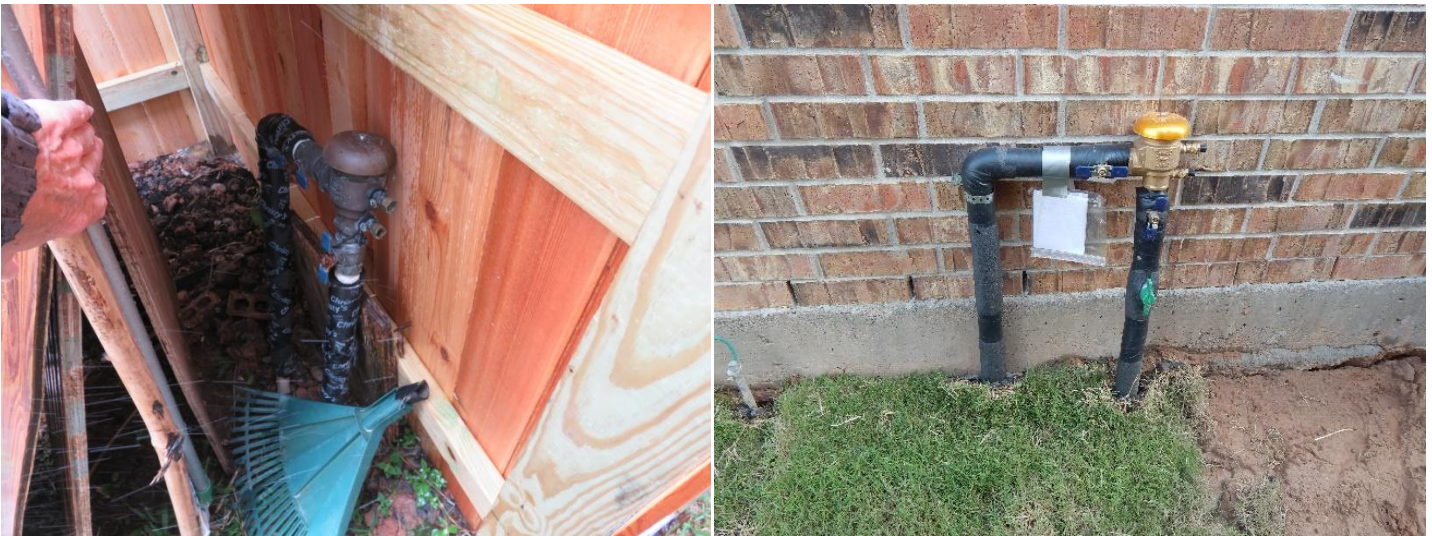
Current and recommended installation

- The backflow preventer should be fully insulated and secured to the structure/fence to prevent accidental movement and damage.

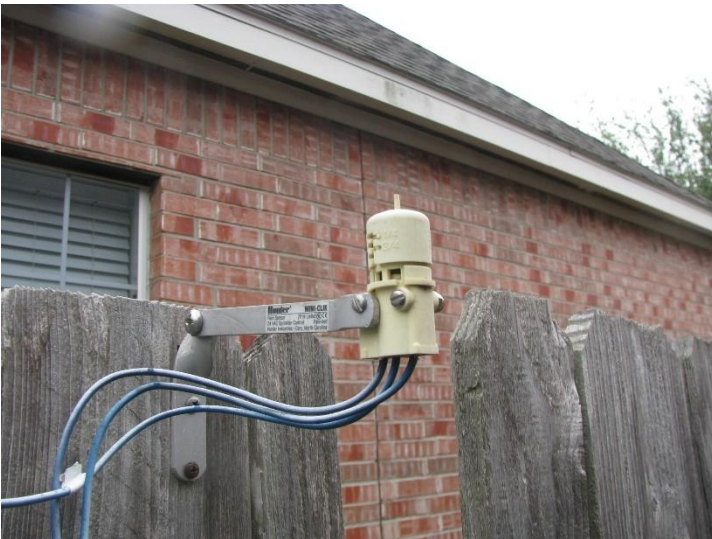
Example of a rain sensor

- The sprinkler system appears to lack a rain sensor that acts as an automatic shut-off during rainy and wet periods.

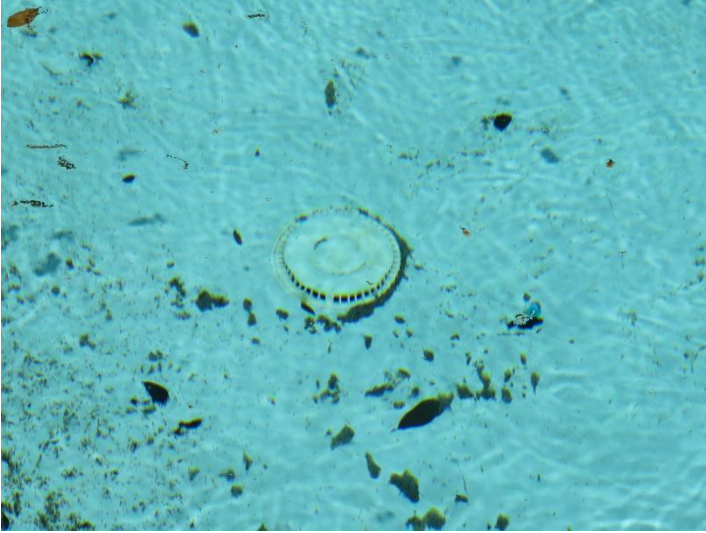
- At least two anti-vortex pool drains a minimum of 3' apart (safety requirement) are required for recirculation of water as well as for draining. There is only one drain in the pool.

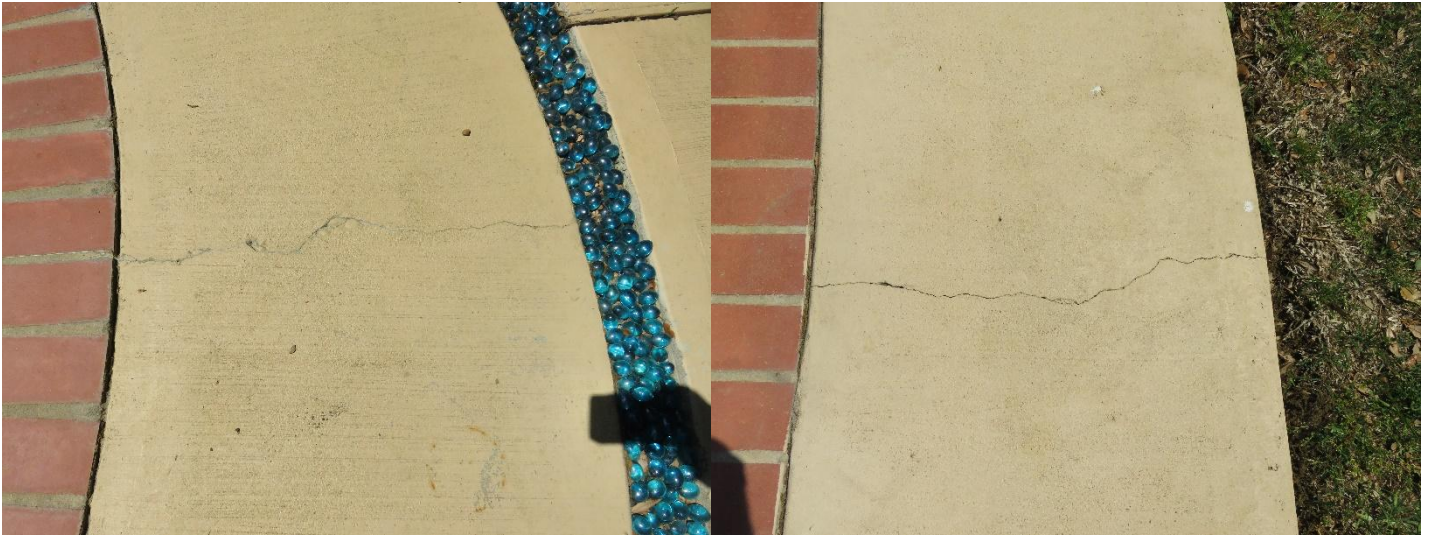
- The pool deck displays several cracks.
