# PROPERTY INSPECTION REPORT

## “AROUND THE HOUSE” HOME INSPECTIONS

By: **David J. Stiles Inspector Lic. #7308** **3/19/2019**

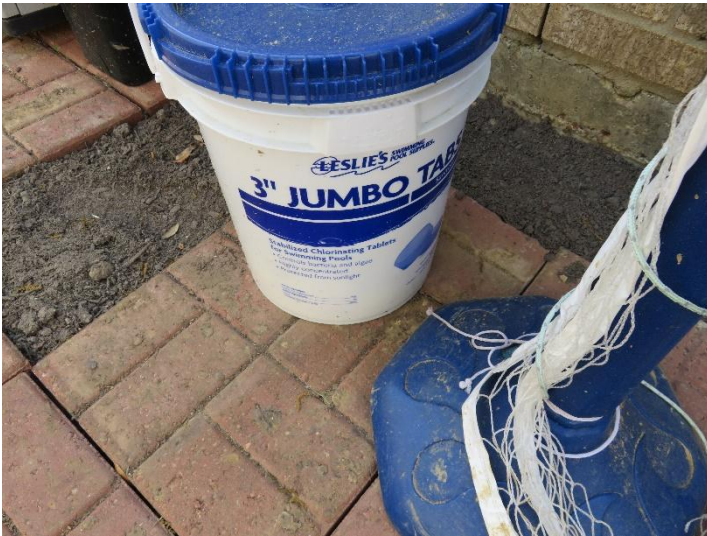
- The method of dispensing chlorine into the pool was unclear.
